Report on  
Preliminary Site Investigation (Contamination)

Redevelopment of Cessnock Correctional Centre  
Lindsay Street, Cessnock

Project 81986.00  
July 2016

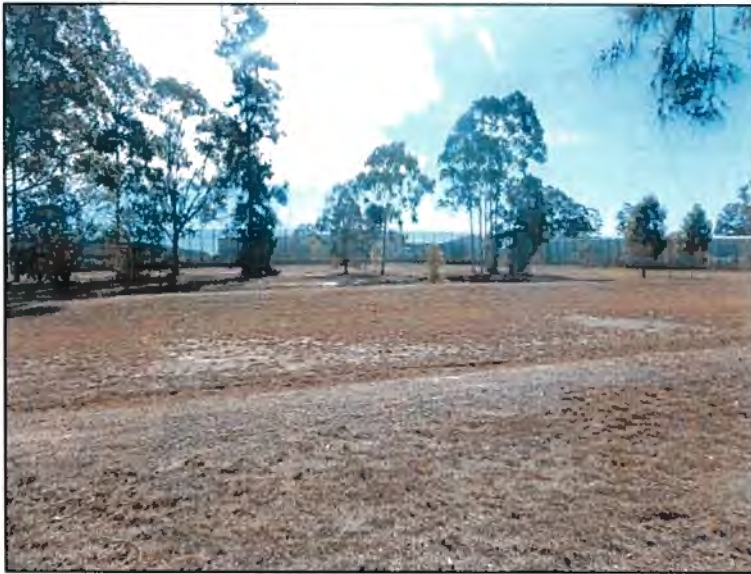
**Figure 2: Area 1 - Facing north towards existing Industries Buildings**

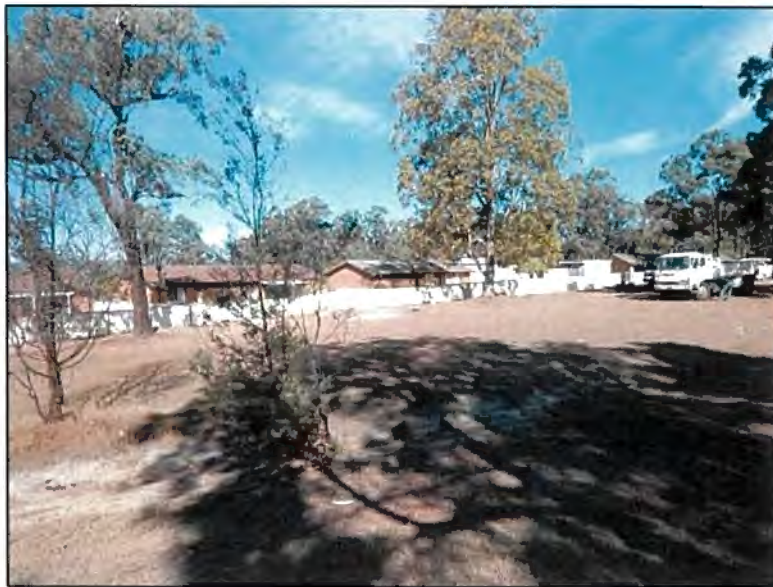
**Figure 3: Area 1 – Facing south-west towards residential housing on Alunga Avenue**

- The possible access road alignment passes along the southern and western perimeter of Area 1 through areas typically grass covered with scattered trees (refer Figure 3).

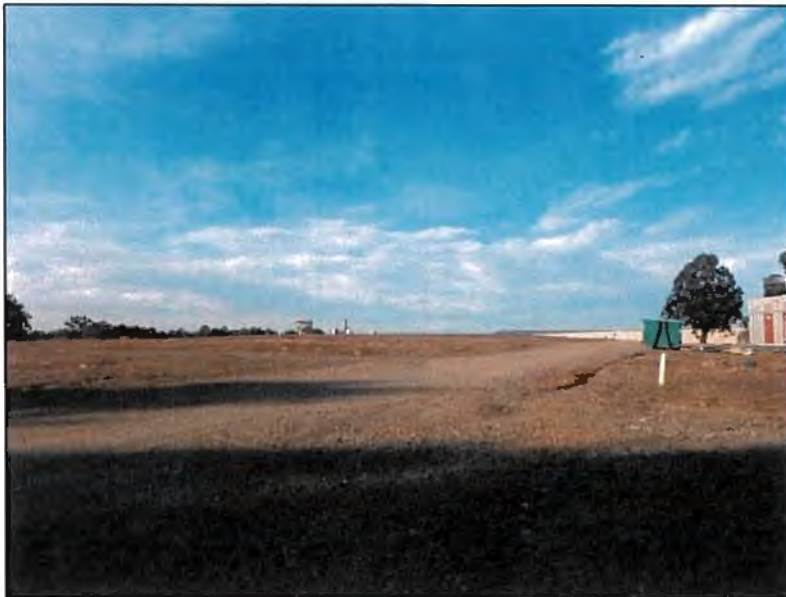
The proposed 320 bed maximum security unit will be constructed to the west of the existing correctional centre, as shown in Figure 4. This area is bounded by the existing maximum security unit to the east, a cluster of demountable buildings to the south and security fencing to the north and west. The site slopes fall to the north and west at about 3 - 5°.

**Figure 4: Area 2 – Facing north-east towards existing correctional**

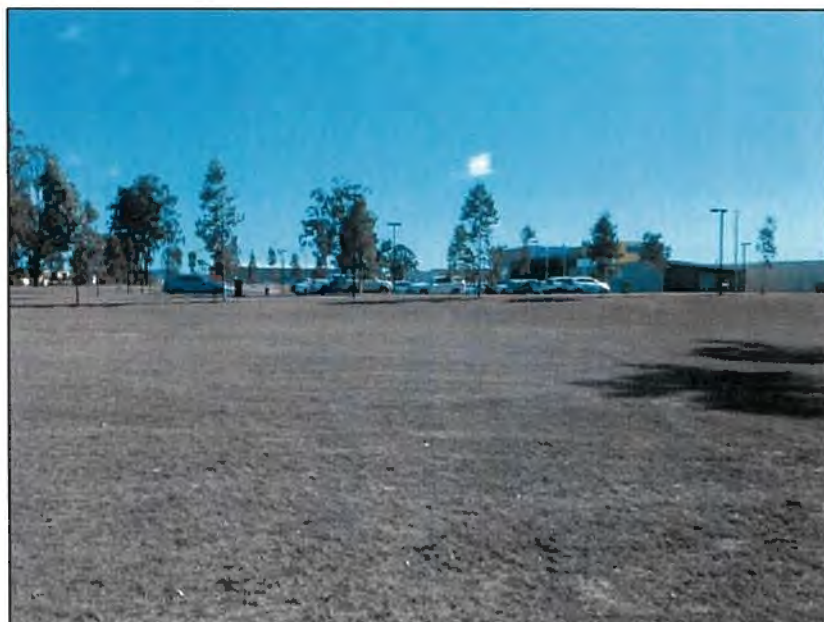
**Figure 5: Area 3 – Facing west towards existing visitor car park**

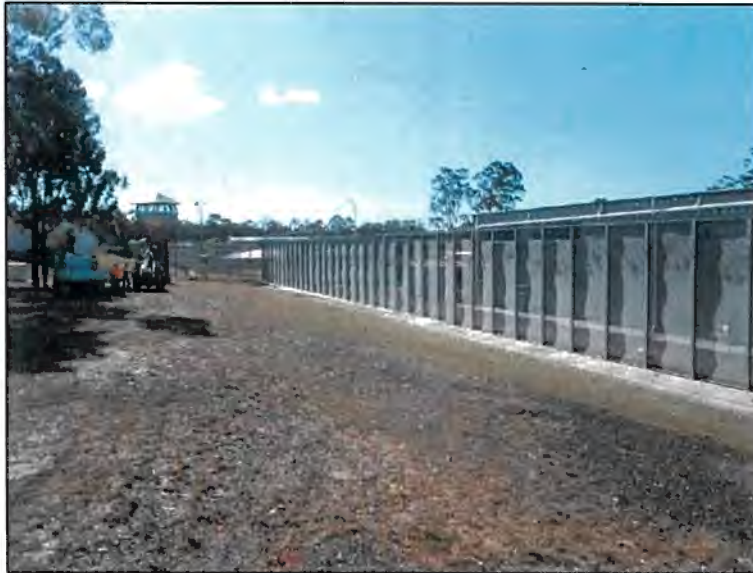
The site slopes typically fall at about 3° to the east in the grassed areas and approximately 1° to the east in car park areas. The surface slopes increase to between 10° to 20° along the northern and eastern boundaries of the area (refer Figure 6).

**Figure 6: Area 3 – Facing north along increased site slopes**

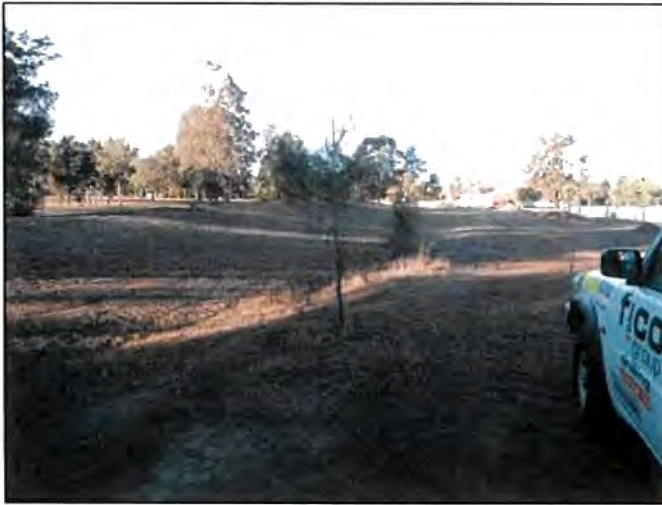
**Figure 8: Drainage swale and bund in Area 1**

- The area is typically grass covered with scattered trees. An existing concrete access road passes in an east/west direction through the northern portion of the proposed development site;
- The site slopes generally fall to the south-east at about 3 - 5°;
- Several swales and bunds are present generally aligned north-east to south-west across the site and appear to act as surface drainage diversions (refer Figure 8);

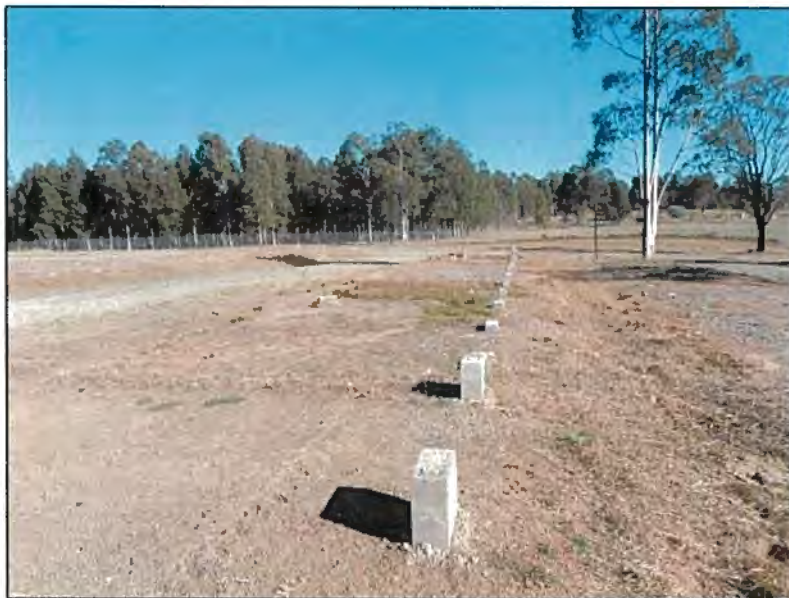
**Figure 9: Area 2 – Demountable building piers and filling terraces**

- At the time of the investigation, the site mostly exposed soil filling at the surface with occasional grassy patches.
- A number of near-level terraces are present across the area which appear to have been formed to allow placement of the previously stored demountable buildings (refer Figure 9). Concrete and cement block footing piers and other building materials associated with the demountable buildings previously stored within this area were scattered across the site, as shown in Figure 9.

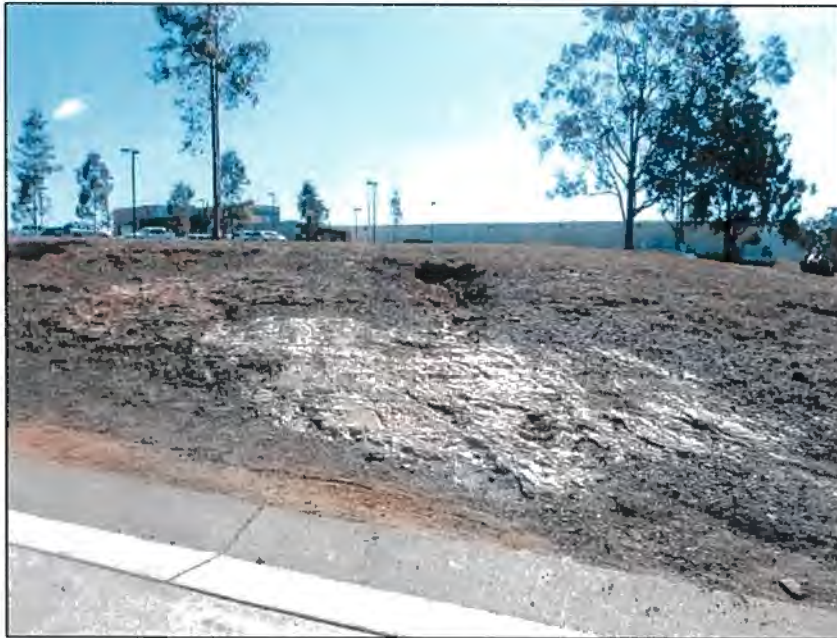
**Figure 10: Area 3 – Rock outcrop towards south-east boundary of Area 3**

- An outcrop of rock, comprising weathered siltstone and sandstone, was present toward the south-eastern extent of Area 3 (refer Figure 10).
