Proposed Expansion of Cessnock Correctional Centre Geotechnical Assessment

Lindsay Street, Cessnock

NEW16P-0119-AD
12 September 2016

**RE: PROPOSED EXPANSION OF CESSNOCK CORRECTIONAL CENTRE
LINDSAY STREET, CESSNOCK
GEOTECHNICAL ASSESSMENT**

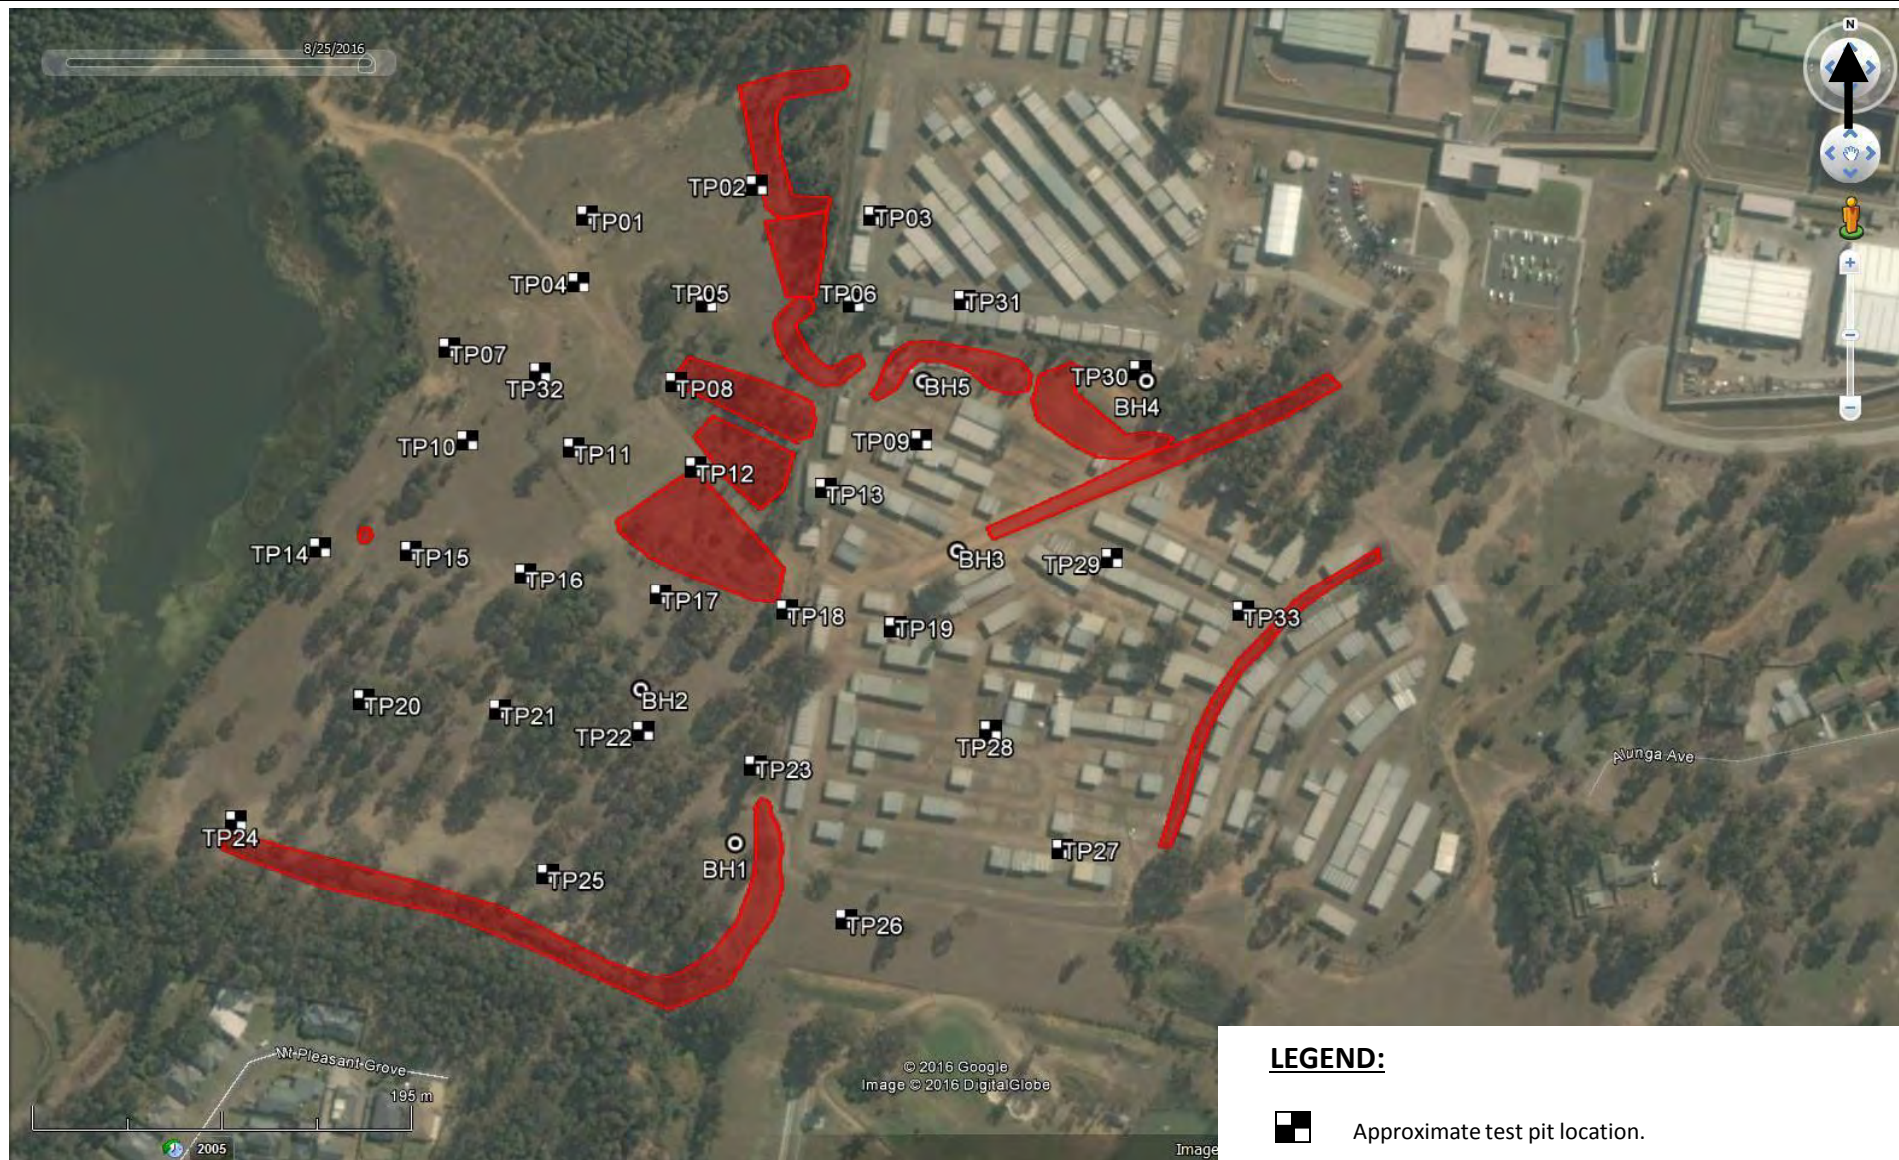
FIGURE AD3:

Excavatability Graph

It also indicates that below depths of about 3m to 4m conditions are mostly expected to range from "hard ripping" to "blasting required". It would be expected that in a large bulk excavation such as that proposed, where ripping directions can be adjusted readily to optimise ripping direction relative to fracture orientation, the majority of rock would be excavatable by a large dozer such as a Caterpillar D9 to D11 or equivalent equipped with a single ripping tine, with allowance for impact ripping, hydraulic breaking and/or pre-splitting in places. Blasting may be required in some areas to achieve normal rates of production.

The discontinuity spacing index has been estimated to an approximate level based on the defect spacings on the engineering logs and core photographs. The approximate range of point load strength index has been adopted based on the results of laboratory point load tests on Unit 6 Weathered Rock recovered from boreholes BH01 to BH05.

Based on Figure AD3, it is assessed that rippability will be highly dependent on three dimensional defect spacing. This assessment has been largely based on the results of boreholes which may be considered to provide 1 dimensional defect spacing information; therefore, it is recommended that consideration be given to potential for different conditions to be encountered when selecting excavation methods and equipment.
