**AHIMS Web Service search for the following area at Lot : 1, DP:DP1035135 with a Buffer of 50 meters, conducted by Chris McGillick on 29 September 2016.**

Re: Proposed Maximum Security Facility, Cessnock Correctional Centre -  
Preliminary Aboriginal Archaeological Assessment (Stage 1)

## Appendix A: Preliminary Aboriginal Archaeological Assessment for the Proposed Development at Cessnock Correctional Centre.

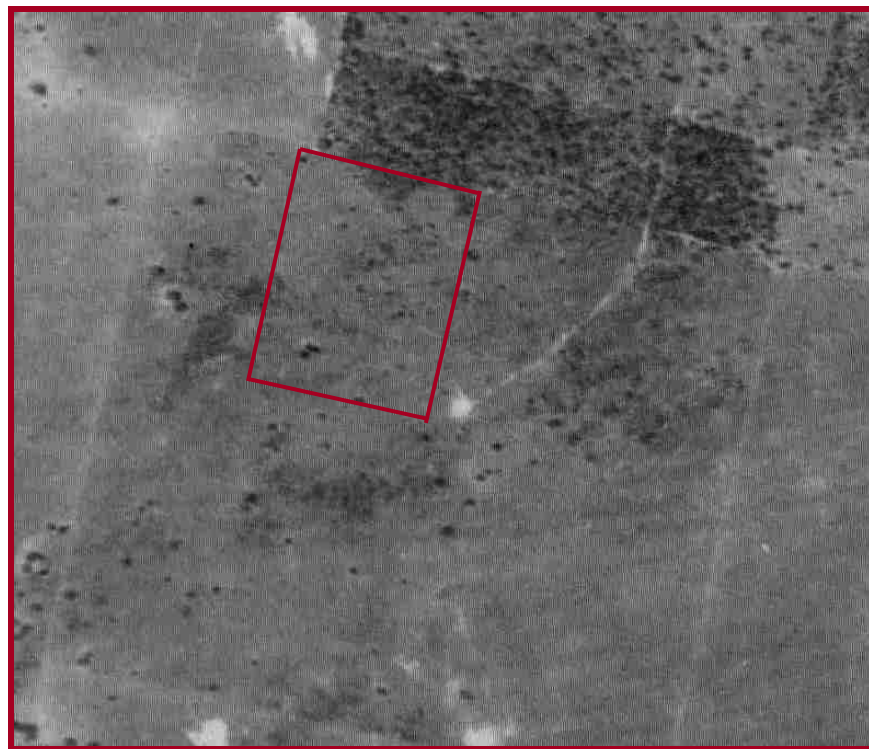
*Figure 4. 1951 aerial photograph showing the study area, with approximate boundaries indicated in red (source: NSW Department of Lands).*

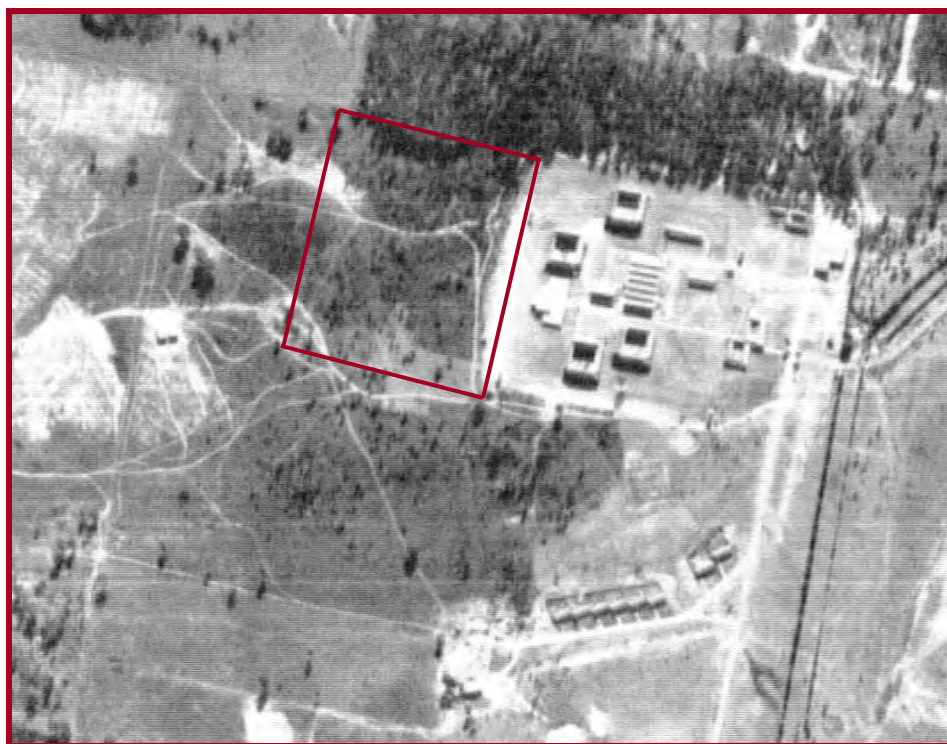
*Figure 6. 1975 aerial photograph showing the study area, with approximate boundaries indicated in red (source: NSW Department of Lands).*

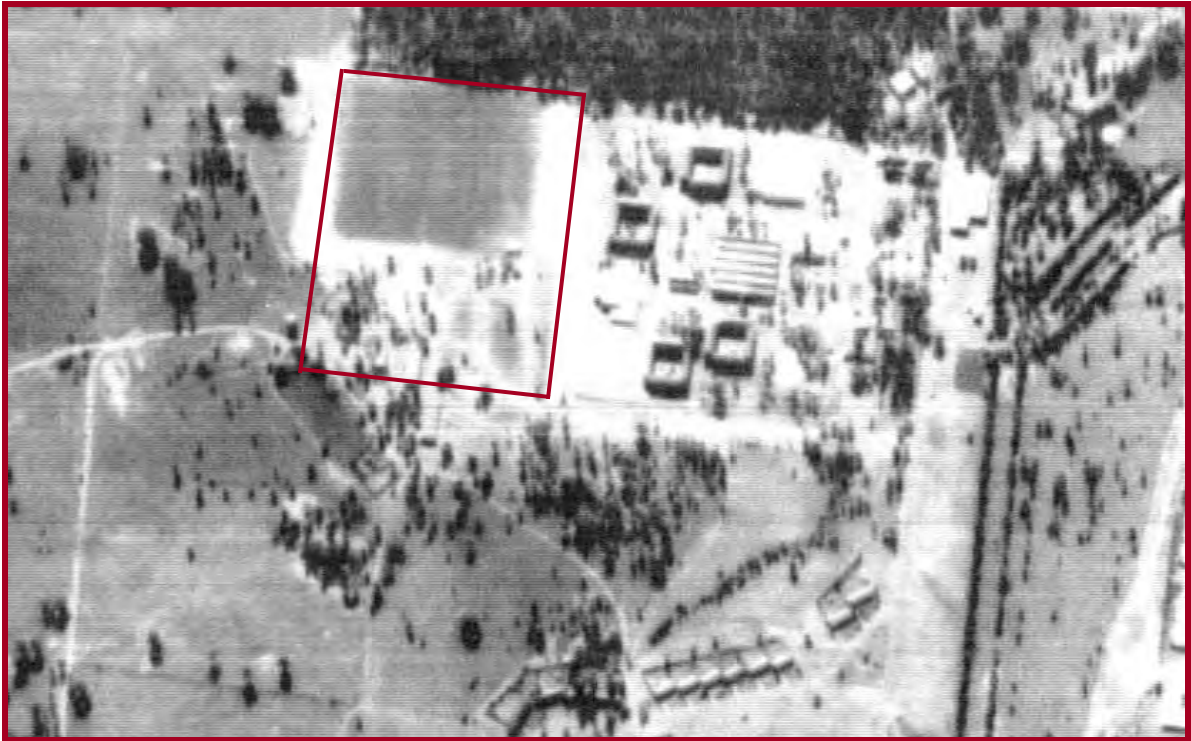
(Figure 7). Levelling of the remainder of the study area, and the construction of the present work shed, has taken place since 1984.

*Figure 7. 1984 aerial photograph showing the study area, with approximate boundaries indicated in red (source: NSW Department of Lands).*

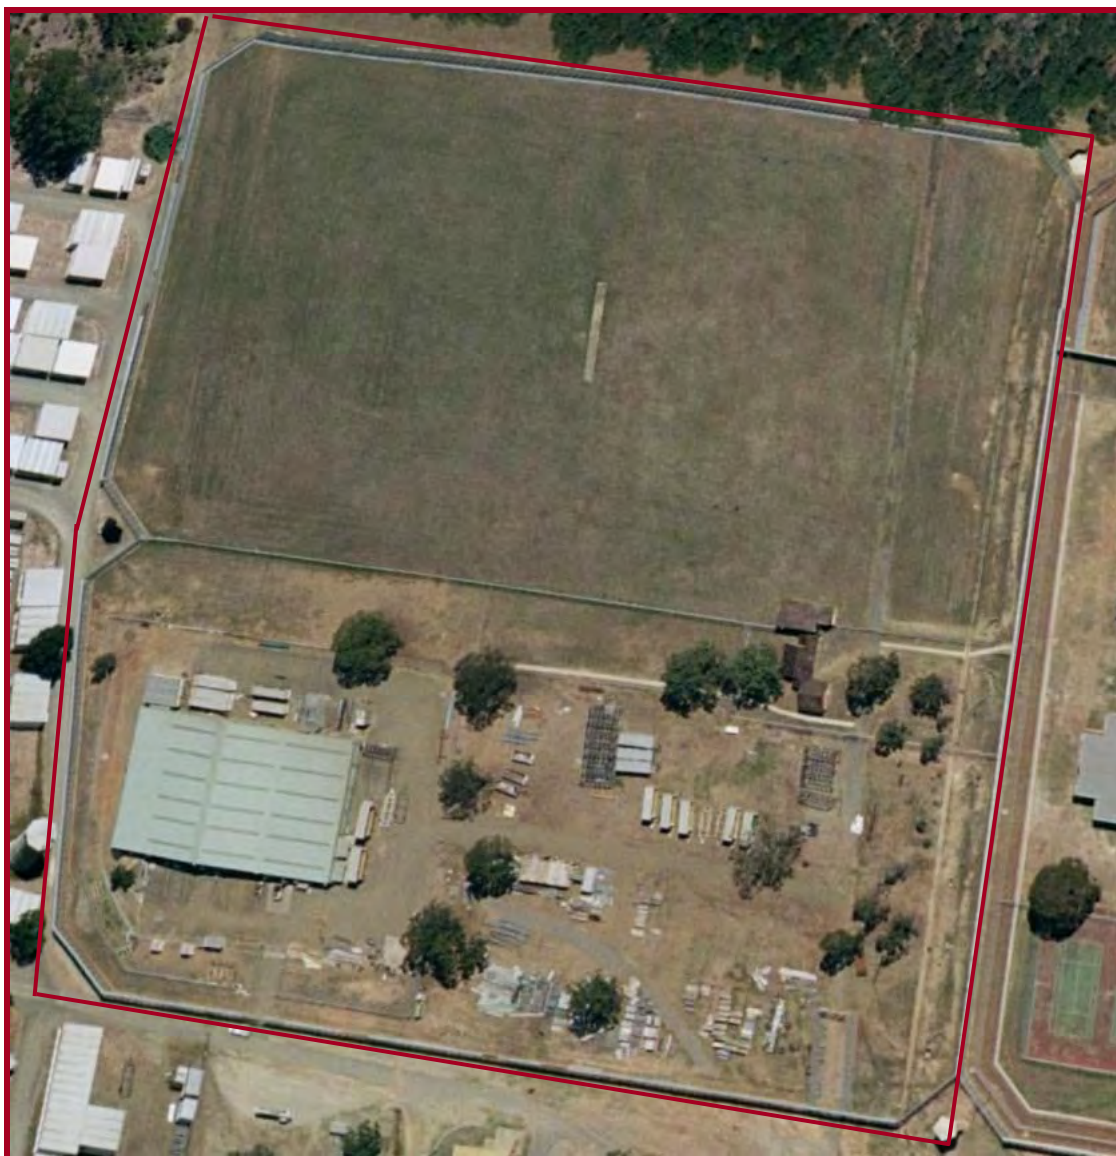
*Figure 9. A recent aerial photograph of the study area, with approximate boundaries indicated in red (source: Google Maps).*

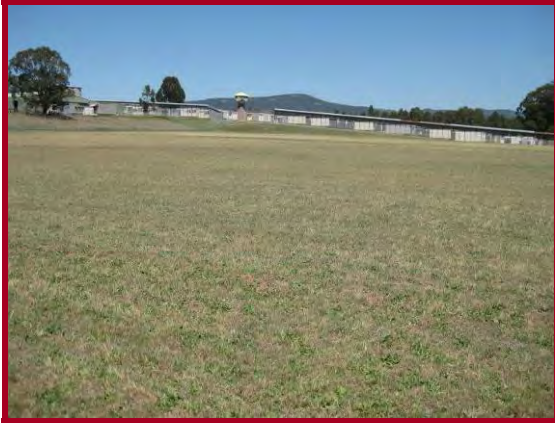
*Figure 10. Looking south-west across the playing field.*

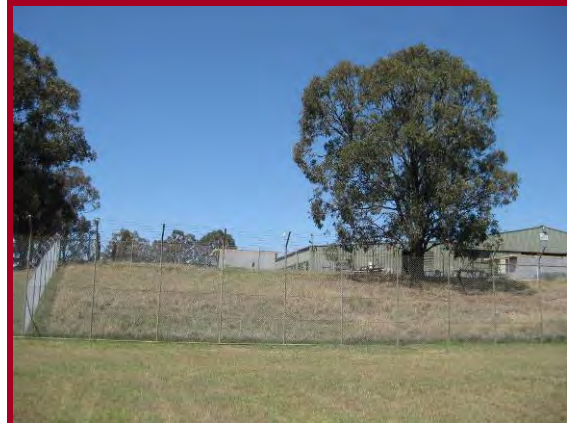
*Figure 11. The break in slope running along the southern boundary of the playing field.*

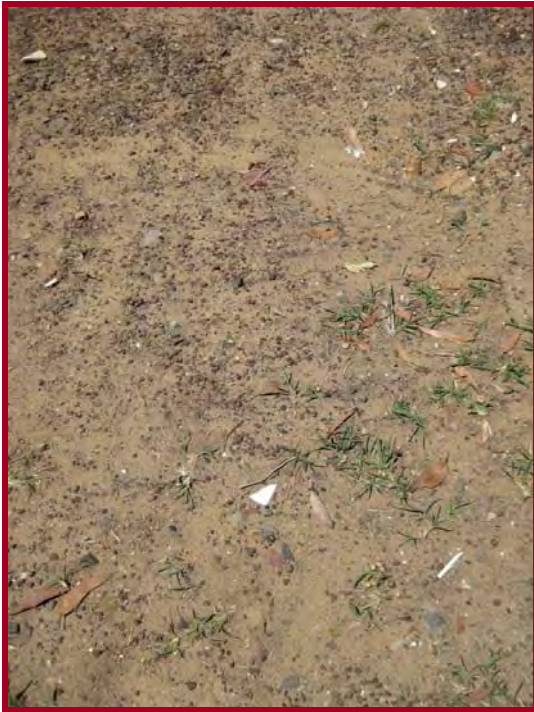
In general, it appears that ground originally sloped down to the north and the east. A substantial amount of fill has been introduced to the study area to create level ground surfaces. It is probable that almost the entire surface of the study area is covered with fill, as the ground exposed in the lowest part, along the eastern boundary, appears to be modern fill. However, it is possible that the ground exposed along the southern boundary of the study area is a disturbed *in situ* subsoil. No Aboriginal objects were found in this area.

Figure 14. Detail of the ground surface in a filled area.

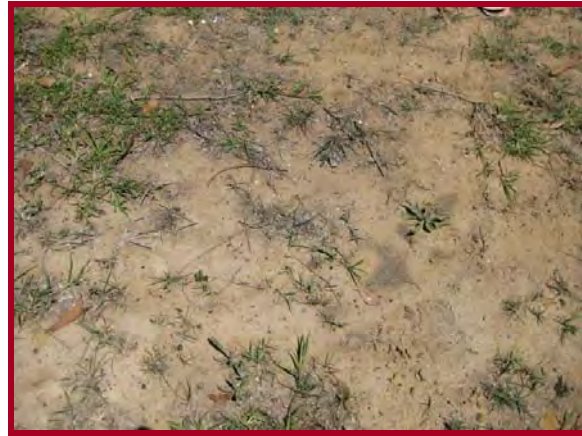
Figure 15. Detail of the ground surface in the south of the study area, showing possibly natural soil.

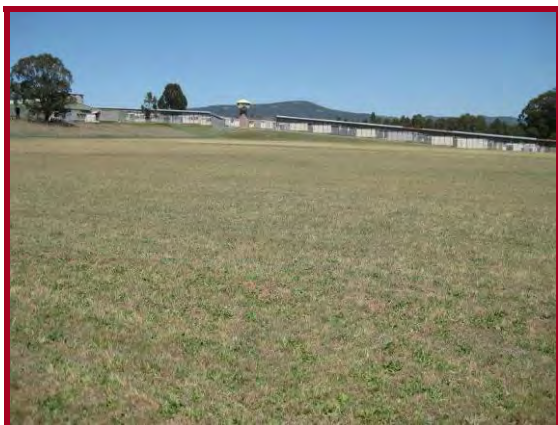
*Figure 10. Looking south-west across the playing field.*

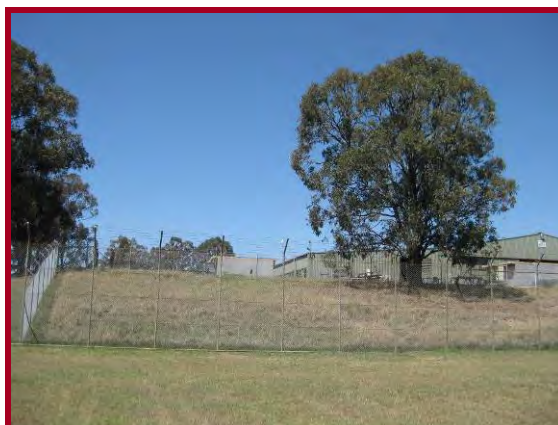
*Figure 11. The break in slope running along the southern boundary of the playing field.*

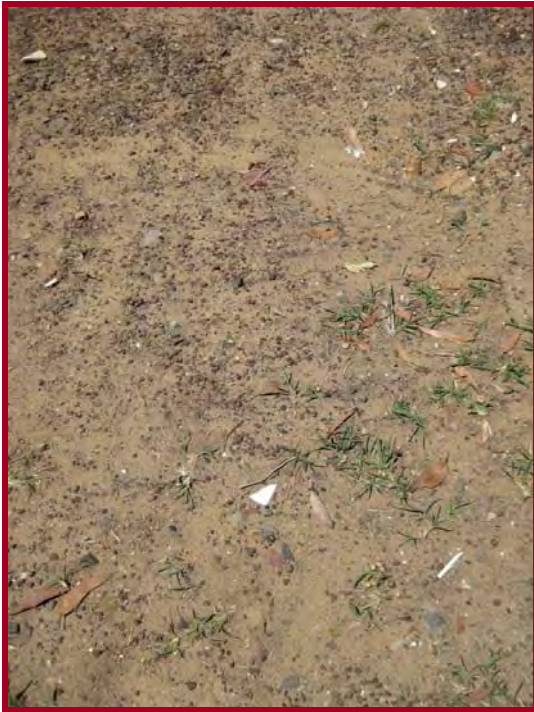
In general, it appears that ground originally sloped down to the north and the east. A substantial amount of fill has been introduced to the study area to create level ground surfaces. It is probable that almost the entire surface of the study area is covered with fill, as the ground exposed in the lowest part, along the eastern boundary, appears to be modern fill. However, it is possible that the ground exposed along the southern boundary of the study area is a disturbed *in situ* subsoil. No Aboriginal objects were found in this area.

Figure 14. Detail of the ground surface in a filled area.

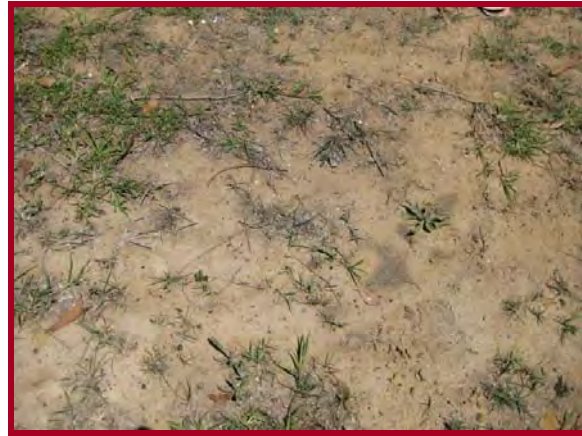
Figure 15. Detail of the ground surface in the south of the study area, showing possibly natural soil.
