Report on
Preliminary Geotechnical Investigation

Proposed Correctional Centre Upgrade
55 The Links Road, South Nowra

Prepared for
Guymer Bailey Architects

Project 48600.06
June 2016

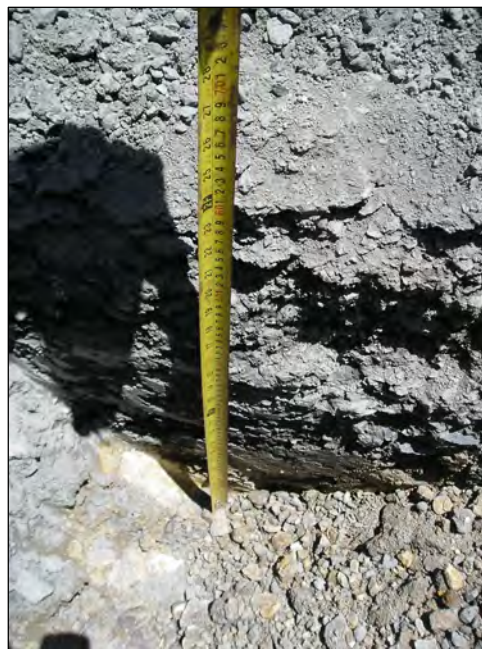
Test Pit Photo 3

0.75	SILTSTONE - low to medium strength, highly to slightly weathered, red brown to grey siltstone Pit discontinued at 0.75m (limit of investigation)			0.75

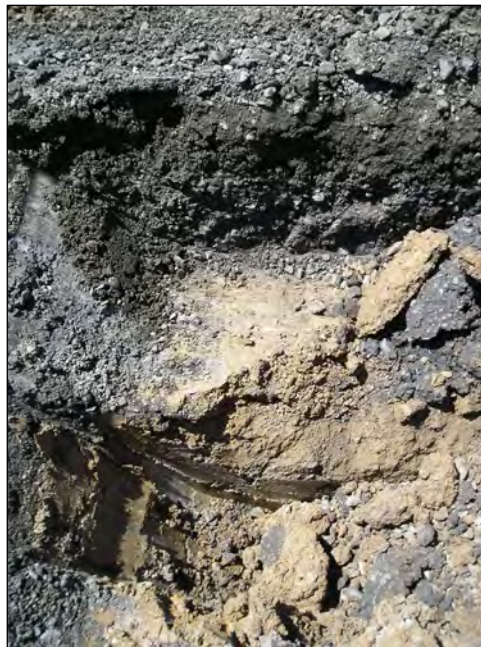
Test Pit Photo 4

B	0.85							
		Pit discontinued at 0.85m (limit of investigation)

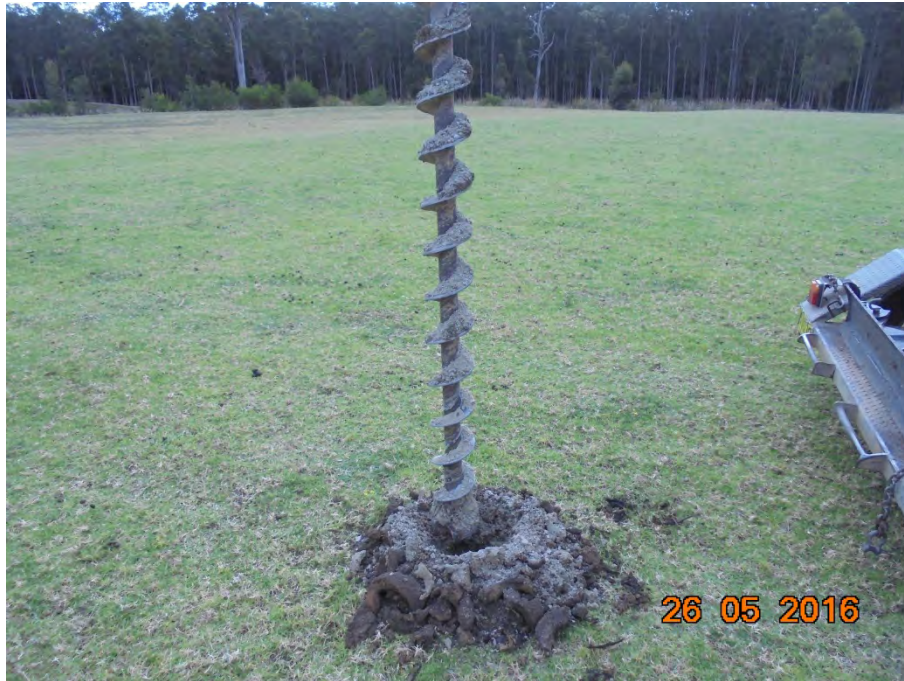
Photo1 – Drilling of Bore 102

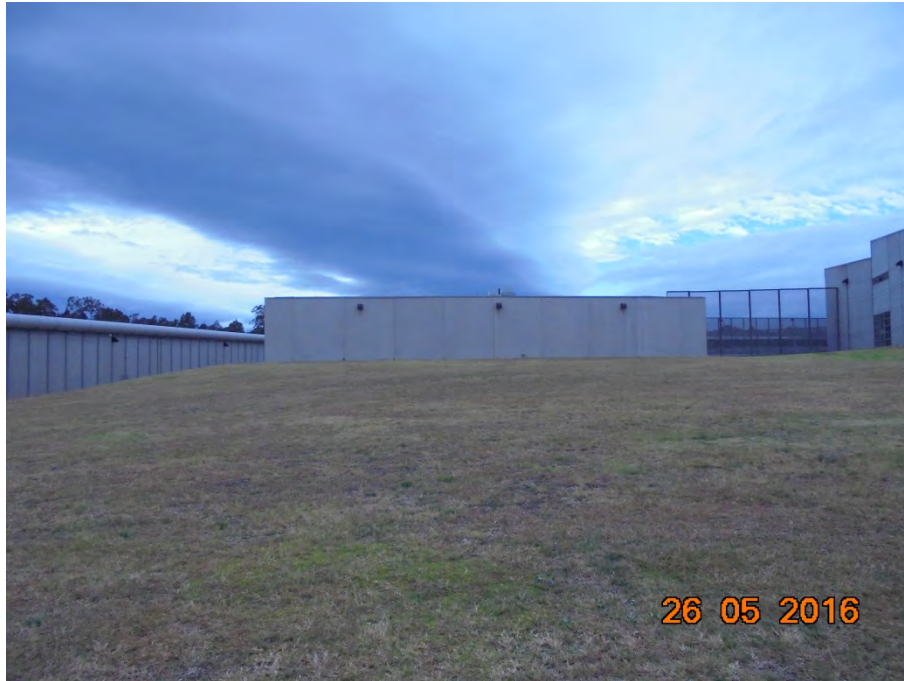
Photo 3 – Location of Bore 108, inside the facility

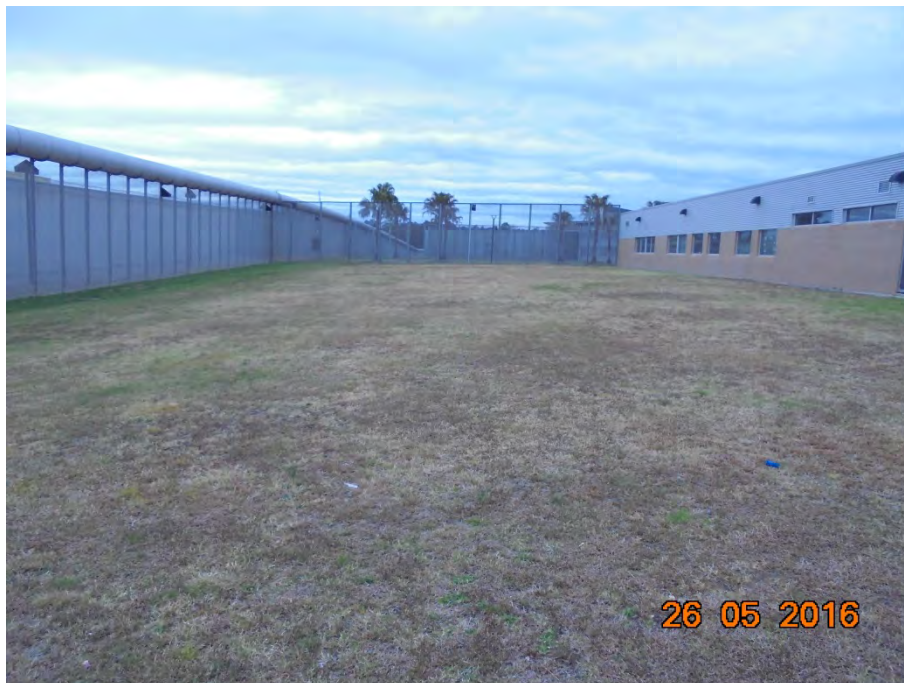
Photo 4 – Location of Bores 106 and 107

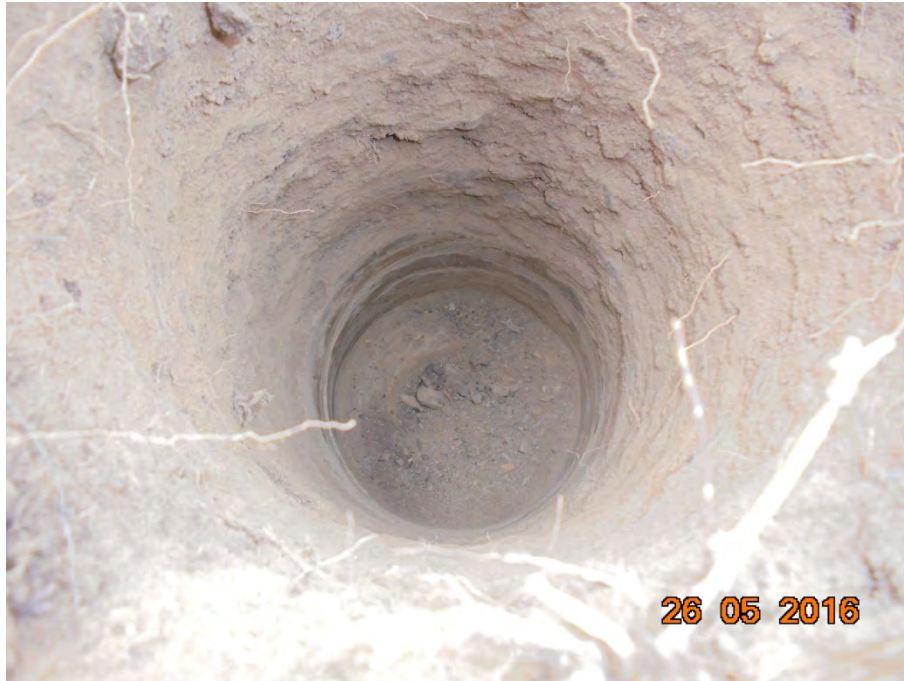
Photo 5 – Gravelly silty clay and sandstone in Bore 107

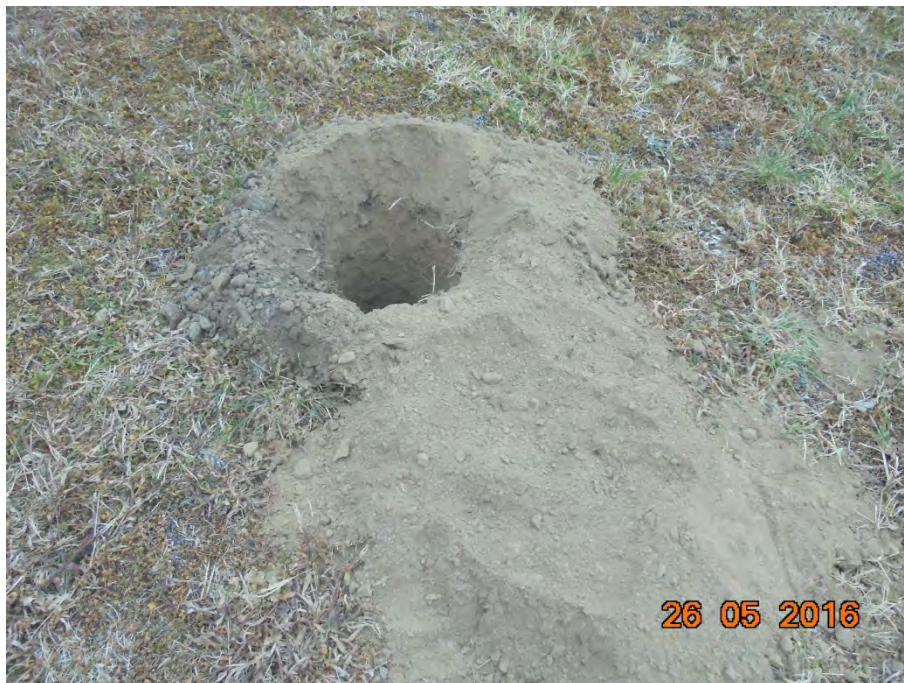
Photo 6 – Spoil generated by Bore 107

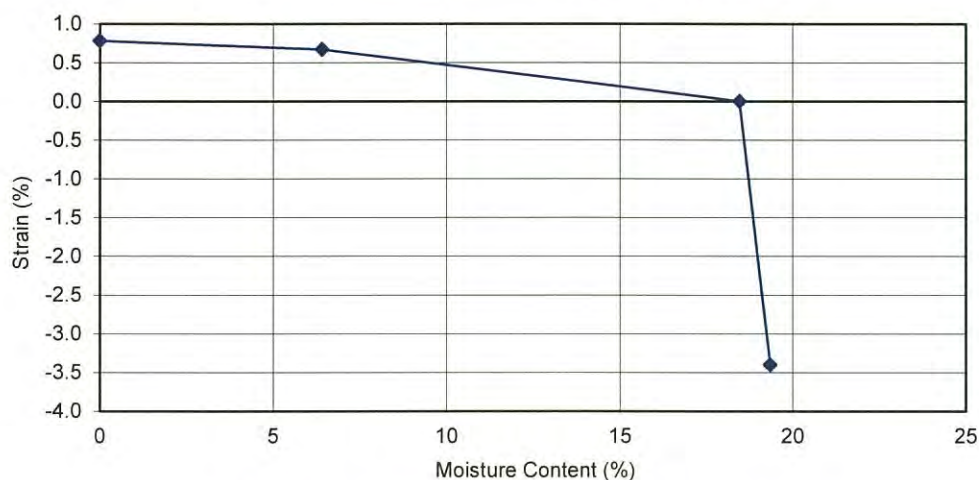
Shrinkage - air dried	0.7 %	Pocket penetrometer reading at initial moisture content	300 kPa
Shrinkage - oven dried	0.8 %	Pocket penetrometer reading at final moisture content	260 kPa
Significant inert inclusions	5.0 %	Initial Moisture Content	18.6 %
Extent of cracking	SC	Final Moisture Content	19.3 %
Extent of soil crumbling	2.0 %	Swell under 25kPa	3.4 %
Moisture content of core	18.5 %

SHRINK-SWELL INDEX I_{ss} 1.4% per ΔpF

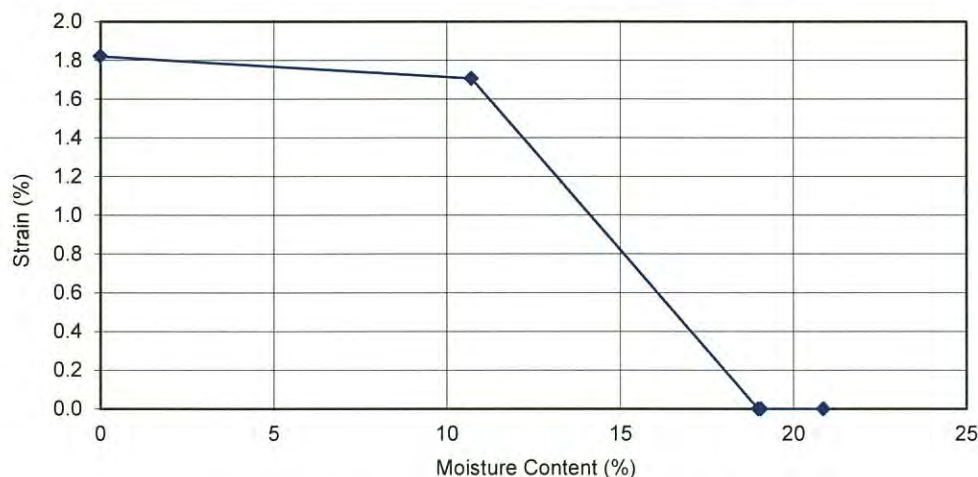
Shrinkage - air dried	1.7 %	Pocket penetrometer reading at initial moisture content	340 kPa
Shrinkage - oven dried	1.8 %	Pocket penetrometer reading at final moisture content	330 kPa
Significant inert inclusions	3.0 %	Initial Moisture Content	20.2 %
Extent of cracking	SC	Final Moisture Content	20.9 %
Extent of soil crumbling	1.0 %	Swell under 25kPa	0.0 %
Moisture content of core	19.1 %

SHRINK-SWELL INDEX I_{ss} 1.0% per ΔpF

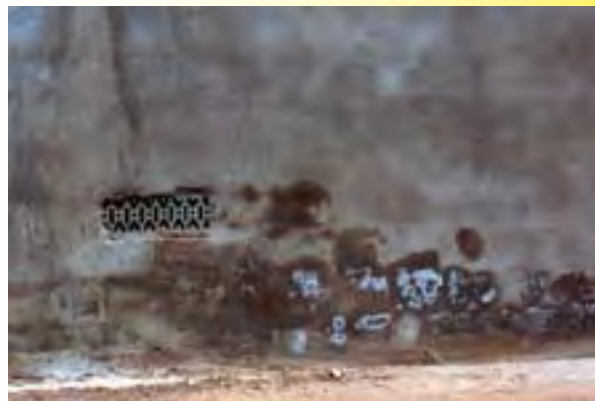
Render showing signs that excess salt and water are present
Photo: NSW Agriculture

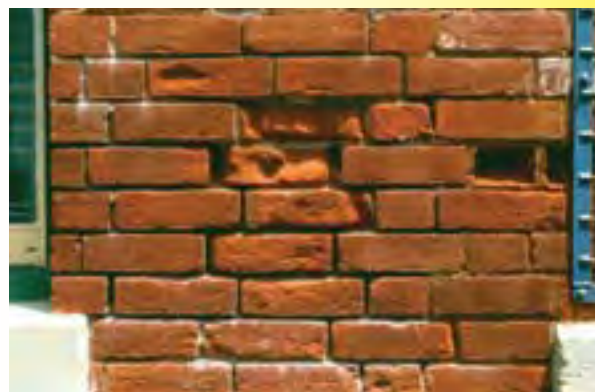
Bricks showing signs of salt and water damage
Photo: NSW Agriculture

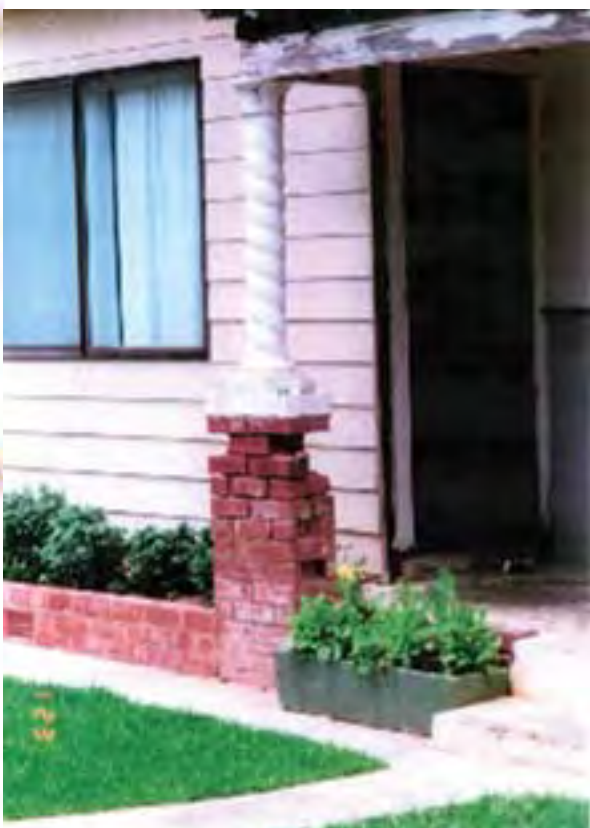
Verandah post showing signs of salt and water damage

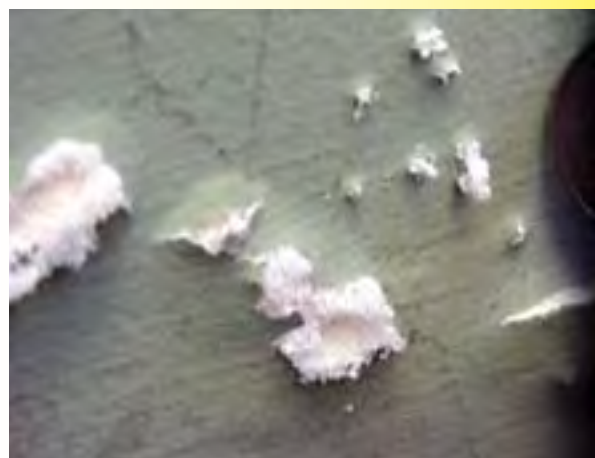
Paintwork blistering due to the accumulation of salt
Photo: DIPNR

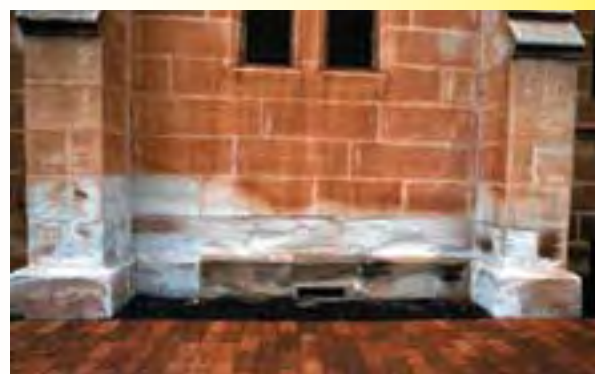
Sandstone showing signs of salt and water damage
Photo: NSW Agriculture

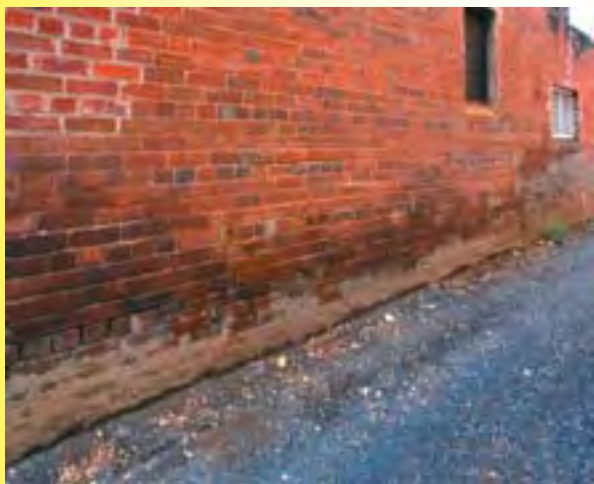
Building with wet 'tide' mark - Photo: NSW Agriculture

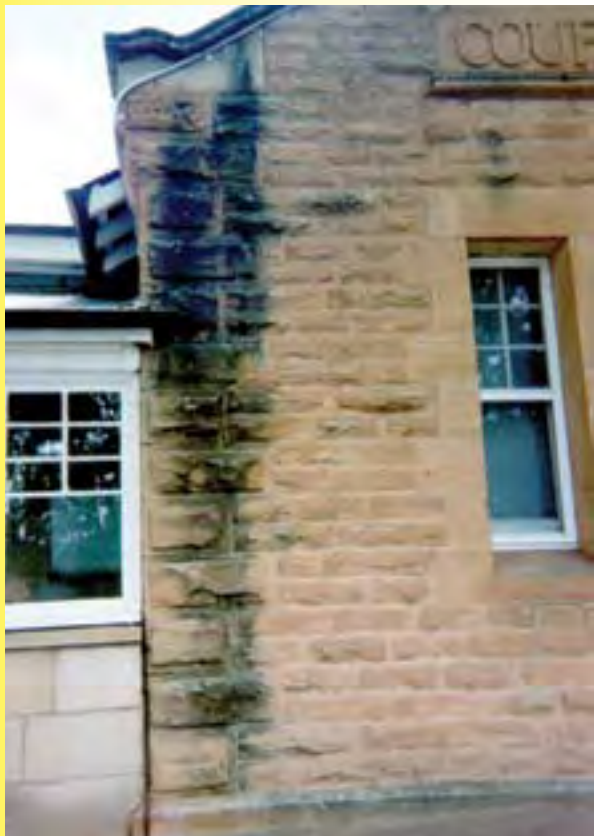
Courthouse showing symptoms of falling damp from a blocked gutter - Photo: NSW Agriculture

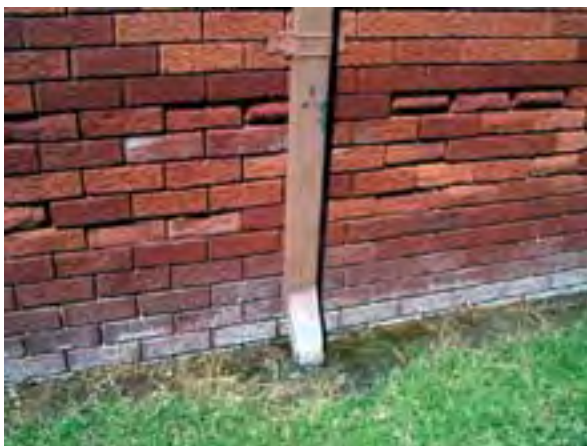
Rusted down pipe allowing rainwater to mobilise salts in the soil. - Photo: DIPNR

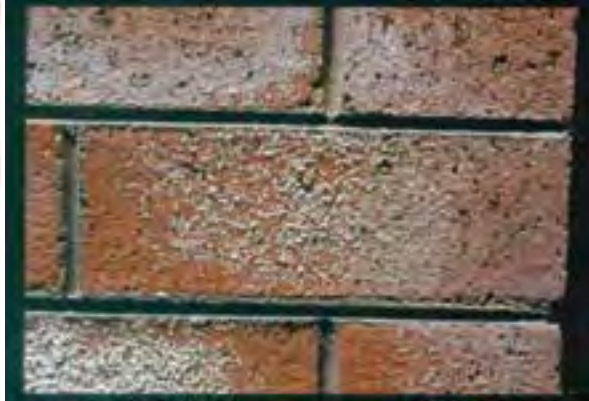
Bricks efflorescing - Photo: NSW Agriculture

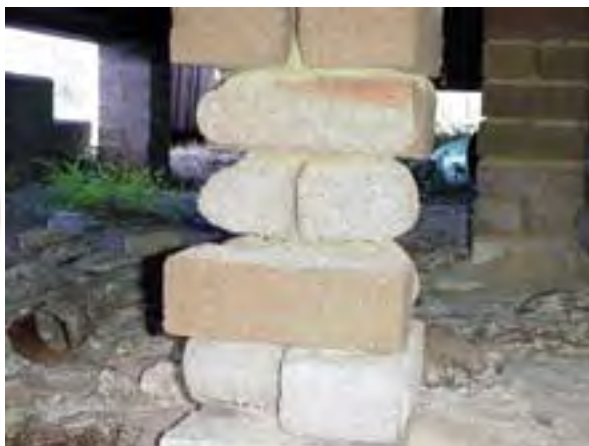
Bricks exhibiting signs of salt and water damage
Photo: DIPNR

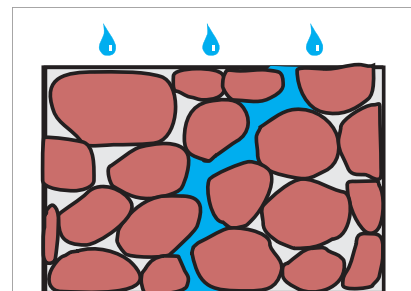
High porosity but low permeability

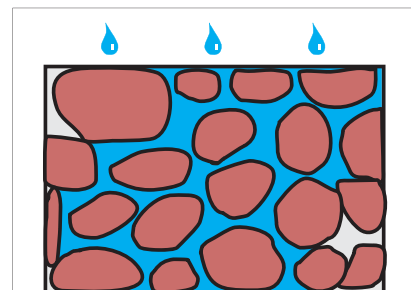
High porosity and high permeability

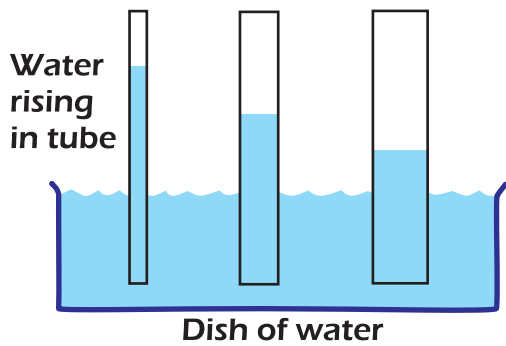
Moisture moves through material towards the surface where evaporation is occurring. The tide mark or height of the water on the wall is the point where the rate of evaporation equals the amount of water getting into, and moving through, the wall. Construction that maintains low permeability, allows increased ventilation and decreased contact between building materials, so sources of water are less likely to cause large areas of salt and water damage.

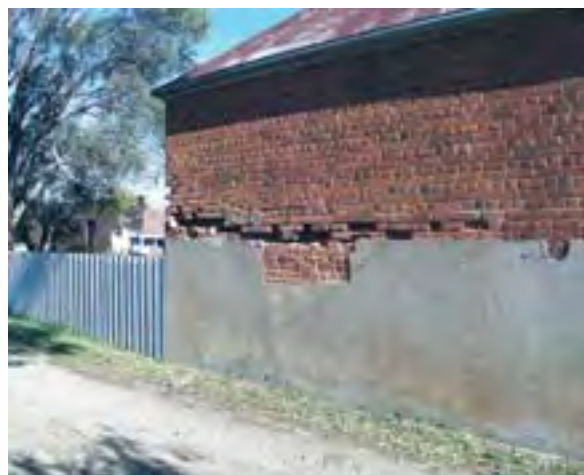
A non permeable render has decreased evaporation
Photo: NSW Agriculture

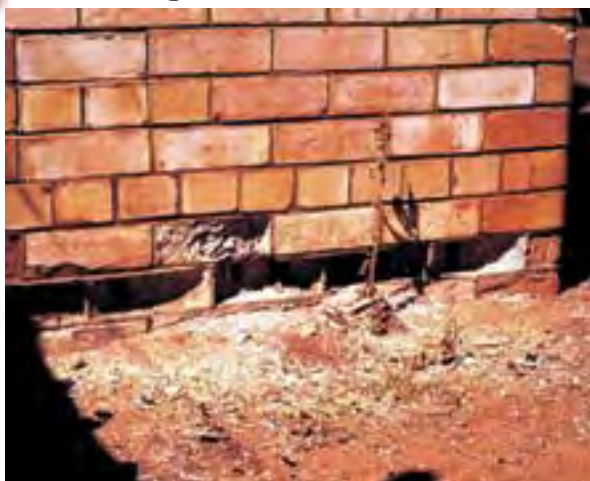
Brick work showing the effects of fretting
Photo: NSW Agriculture

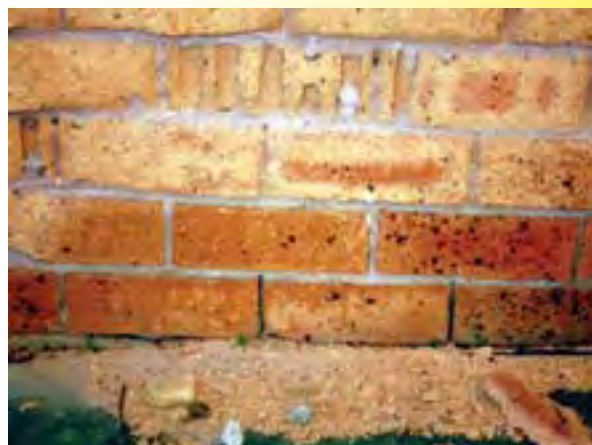
Brick work showing the effects of fretting and the accumulation of brick 'grains' at the base of the wall
Photo: DIPNR

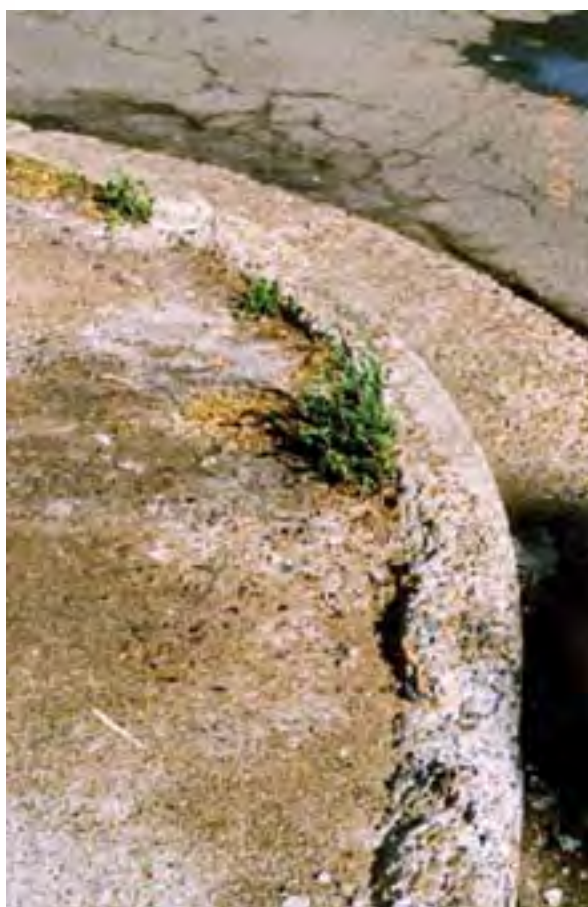
Kerb and guttering affected by sulphates
Photo: DIPNR

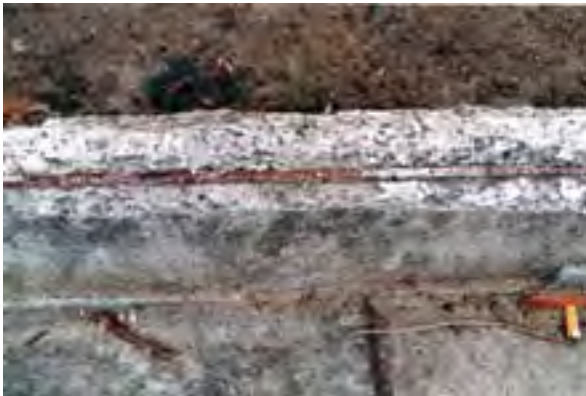
Reinforcing steel exposed and corroding
Photo: DIPNR

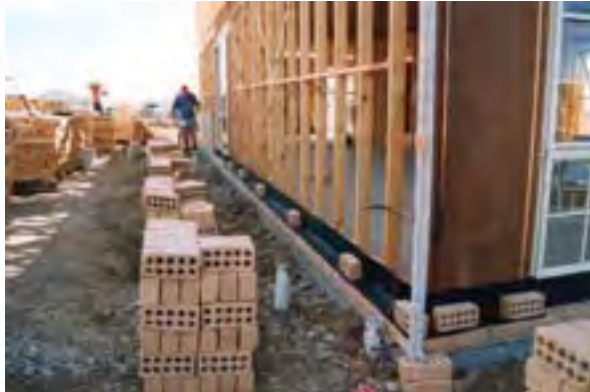
Installation of polyethylene sheeting in mortar joint of the brick work - Photo: DIPNR

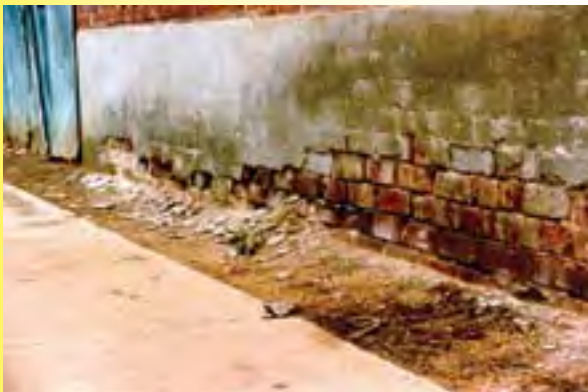
Damp-proof course has been bypassed by rendering
Photo: NSW Agriculture

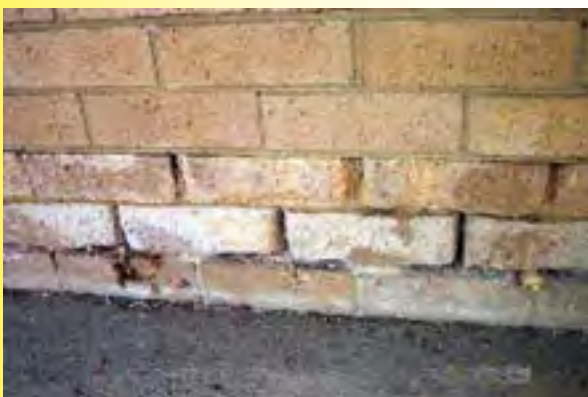
Damp-proof course limiting damage to lower three bricks
Photo: DIPNR

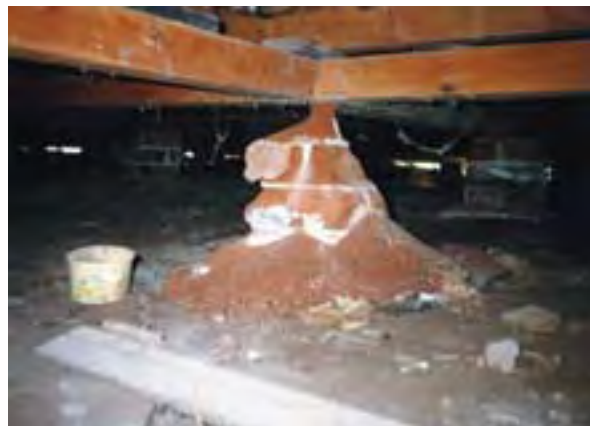
Damage discovered during a building inspection

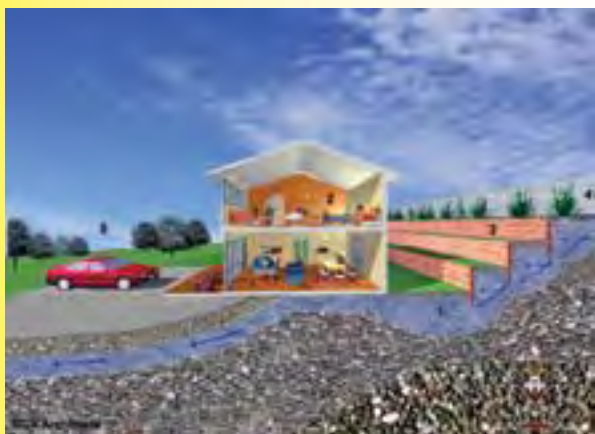
Water flow obstructed by urban development
Diagram: DIPNR- Greener Subdivision project

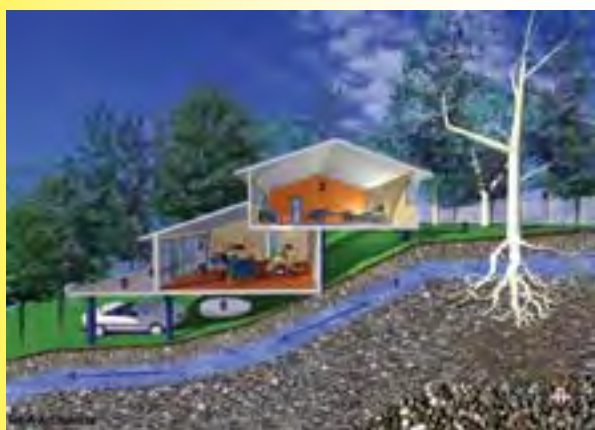
Water flow not obstructed by urban development
Diagram: DIPNR- Greener Subdivision project

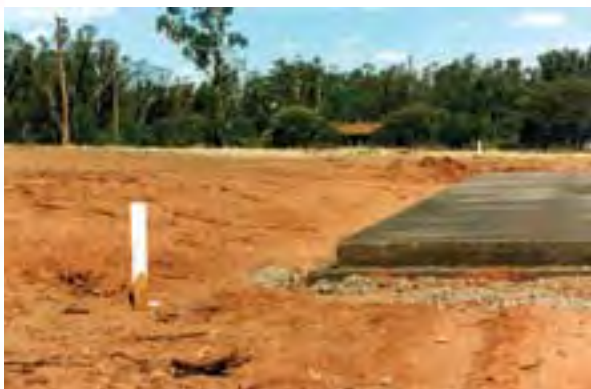
Typical slab on ground construction. - Photo: DIPNR

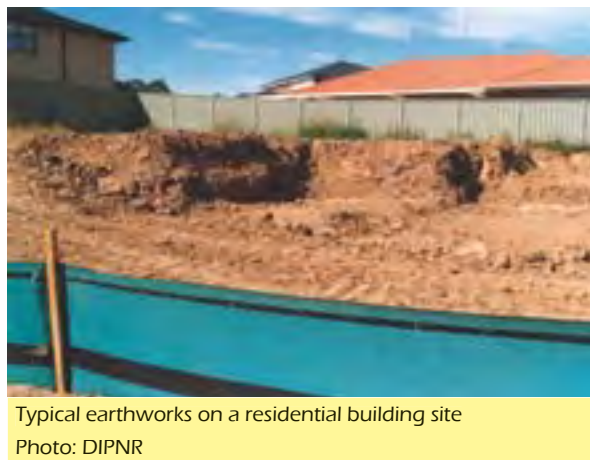
Typical earthworks on a residential building site
Photo: DIPNR

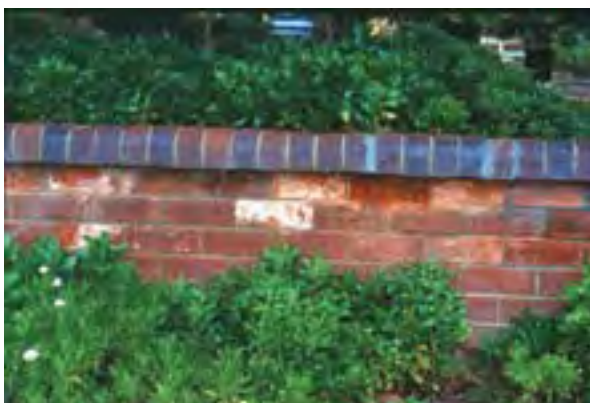
Non exposure grade bricks used in a garden wall
Photo: NSW Agriculture

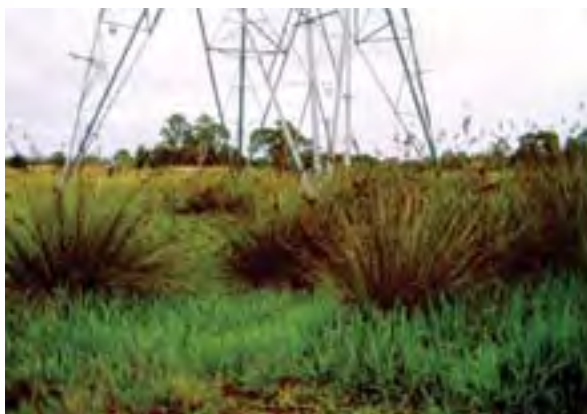
Electricity supply pole with salinity vegetation indicators
Photo:DIPNR

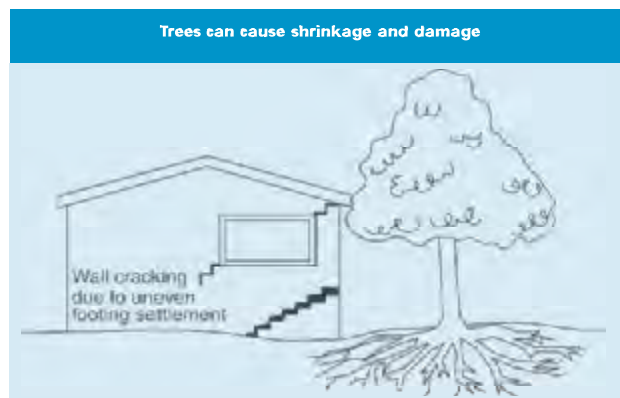
As the weather pattern changes and the soil begins to dry out, the external footings will be first affected, beginning with the locations where the sun's effect is strongest. This has the effect of lowering the external footings. The doming is accentuated and cracking reduces or disappears where it occurred because of dishing, but other cracks open up. The roof lines may become convex.
