Report on
Geotechnical Investigation

Redevelopment of Cessnock Correctional Centre
Lindsay Street, Cessnock

Prepared for
NBRS & Partners Pty Ltd

Project 81986.00
July 2016

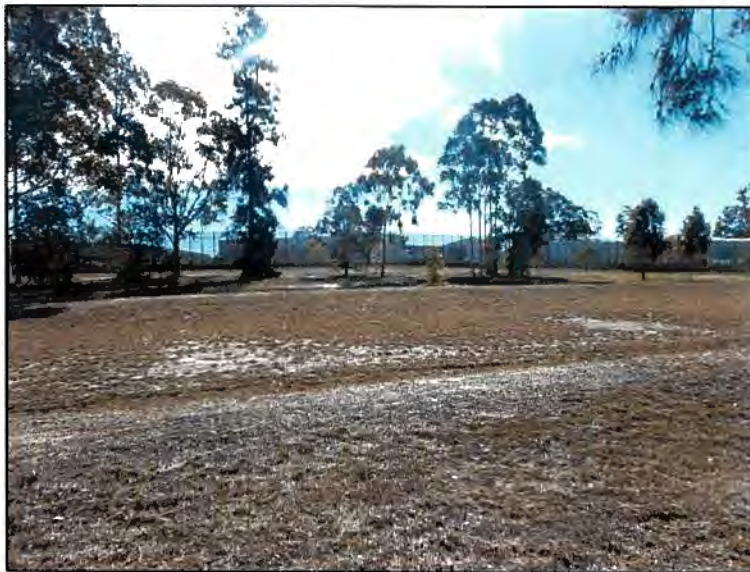
Figure 2: Area 1 - Facing north towards existing Industries Buildings

The proposed 280 bed minimum security unit will be constructed south of the existing correctional facility between the existing Industries Building to the north and existing residential housing on Alunga Avenue, as shown in Figure 2 and Figure 3.

The area is typically grass covered with scattered trees. An existing concrete access road passes in an east/west direction through the northern portion of the proposed development site.

The site slopes generally fall to the south-east at about 3° - 5°. Several water diversion bunds extending to the east and west have been constructed perpendicular to the site slope.

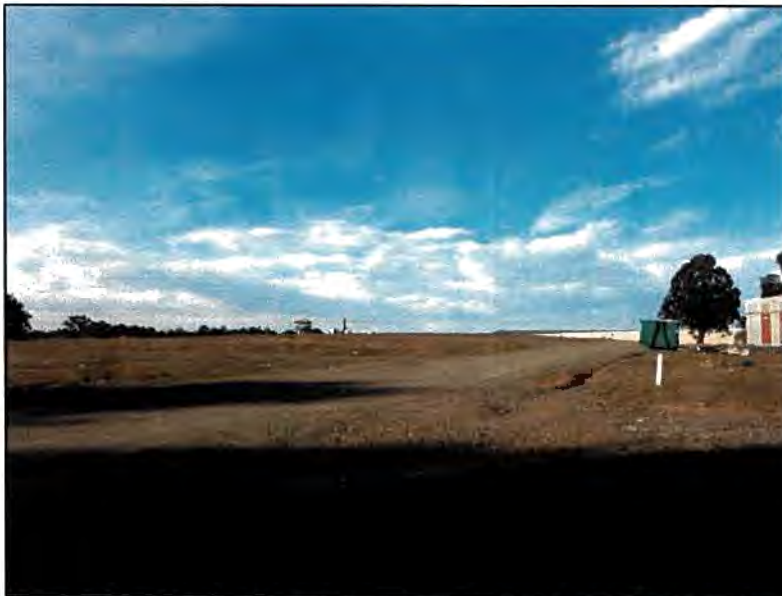
Figure 4: Area 2 – Facing north-east towards existing correctional centre

The proposed 320 bed maximum security unit will be constructed to the west of the existing correctional facility, as shown in Figure 4. This area is bounded by the existing maximum security unit to the east, a cluster of demountable buildings to the south and security fencing to the north and west with bushland beyond. The site slopes fall to the north and west at about 3 - 5°.

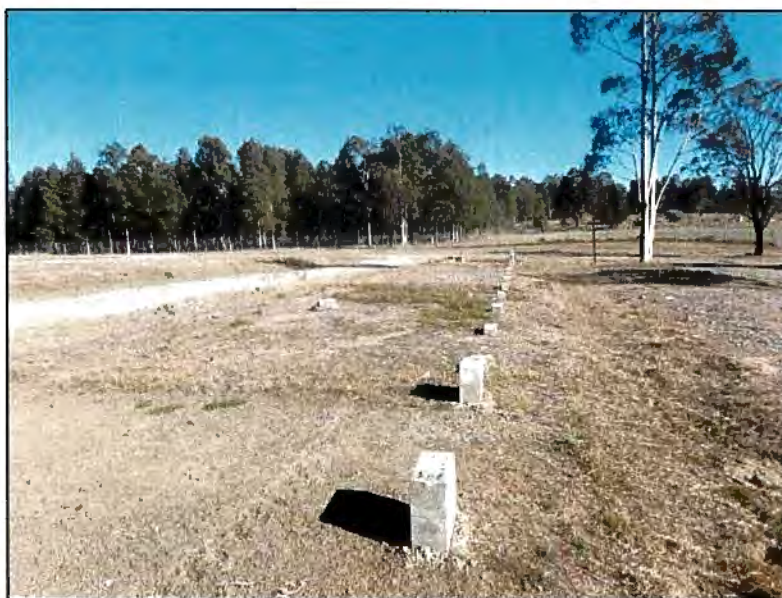
Figure 5: Area 2 – Demountable building piers and filling terraces

At the time of the investigation, the site mostly exposed soil filling at the surface with occasional grassy patches. A number of near-level terraces are present across the area which appear to have been formed to allow placement of the previously stored demountable buildings (refer Figure 5). The previously stored demountable buildings are shown on Drawing 1 in Appendix D, which is based on a 2010 Google Earth image of the site. Concrete and cement block footing piers and other building materials associated with the demountable buildings previously stored within this area were scattered across the site, as shown in Figure 5.

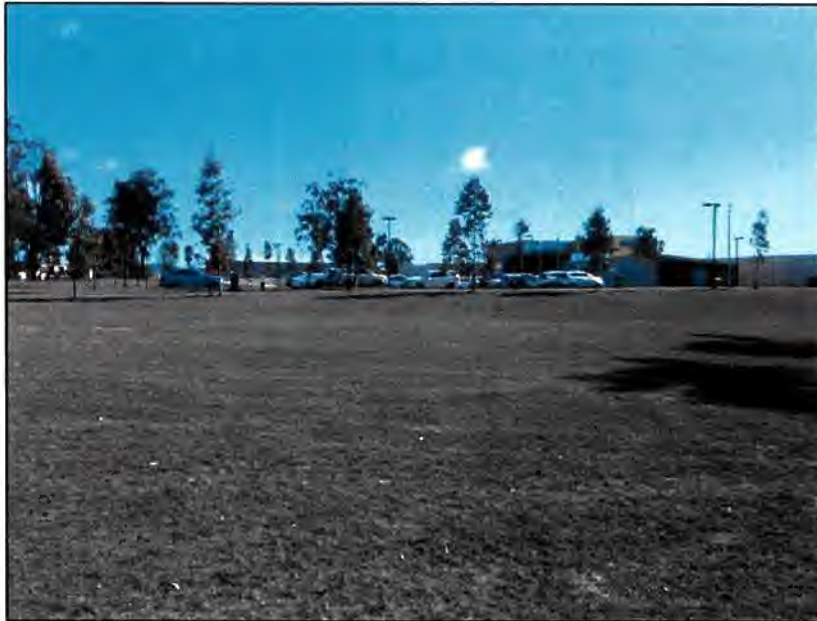
Figure 6: Area 3 – Facing west towards existing visitor car park

The proposed staff amenities and car park will be constructed immediately south of the existing maximum security entrance, adjacent to the existing staff and visitor car park areas (refer Figure 6). The area was generally grassed areas with some scattered trees. The existing car parking areas were asphalt sealed with a combination of asphalt and concrete access roads.

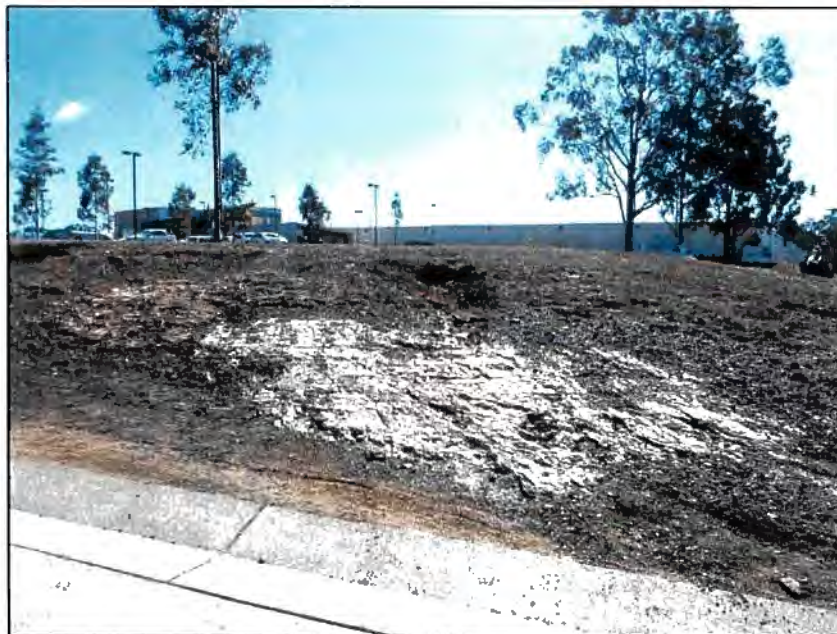
Figure 7: Area 3 – Rock outcrop towards south-east boundary of Area 3

An outcrop of rock, comprising weathered siltstone and sandstone, was present toward the south-eastern extent of Area 3 (refer Figure 7).

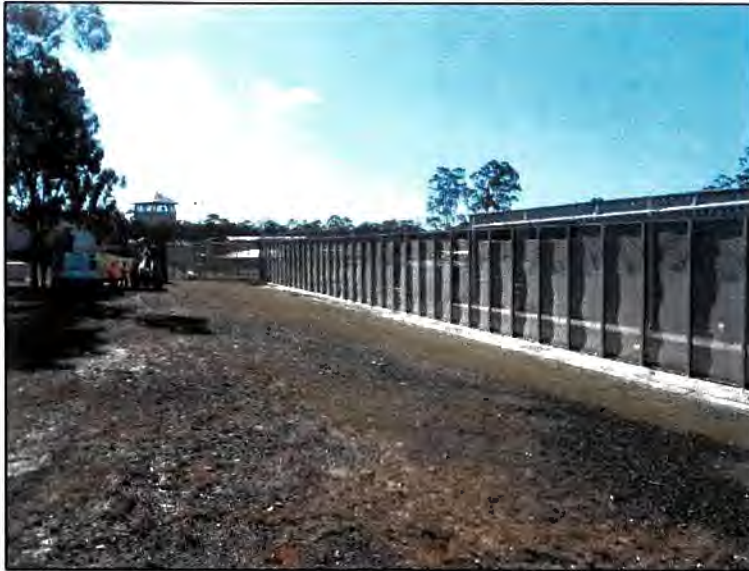
Figure 8: Area 3 – Facing north along eastern perimeter of Area 3 with increased site slopes

The site slopes typically fall at about 3° to the east in the grassed areas and approximately 1° to the east in car park areas. The surface slopes increase to between 10° to 20° along the northern and eastern boundaries of the area (refer Figure 8).
