13 July 2018

Lend Lease
30 The Bond, 30 Hickson Road
Millers Point NSW 2000

**RE: PROPOSED EXPANSION OF CESSNOCK CORRECTIONAL CENTRE, NSW
ASBESTOS IN SOIL MANAGEMENT PLAN**

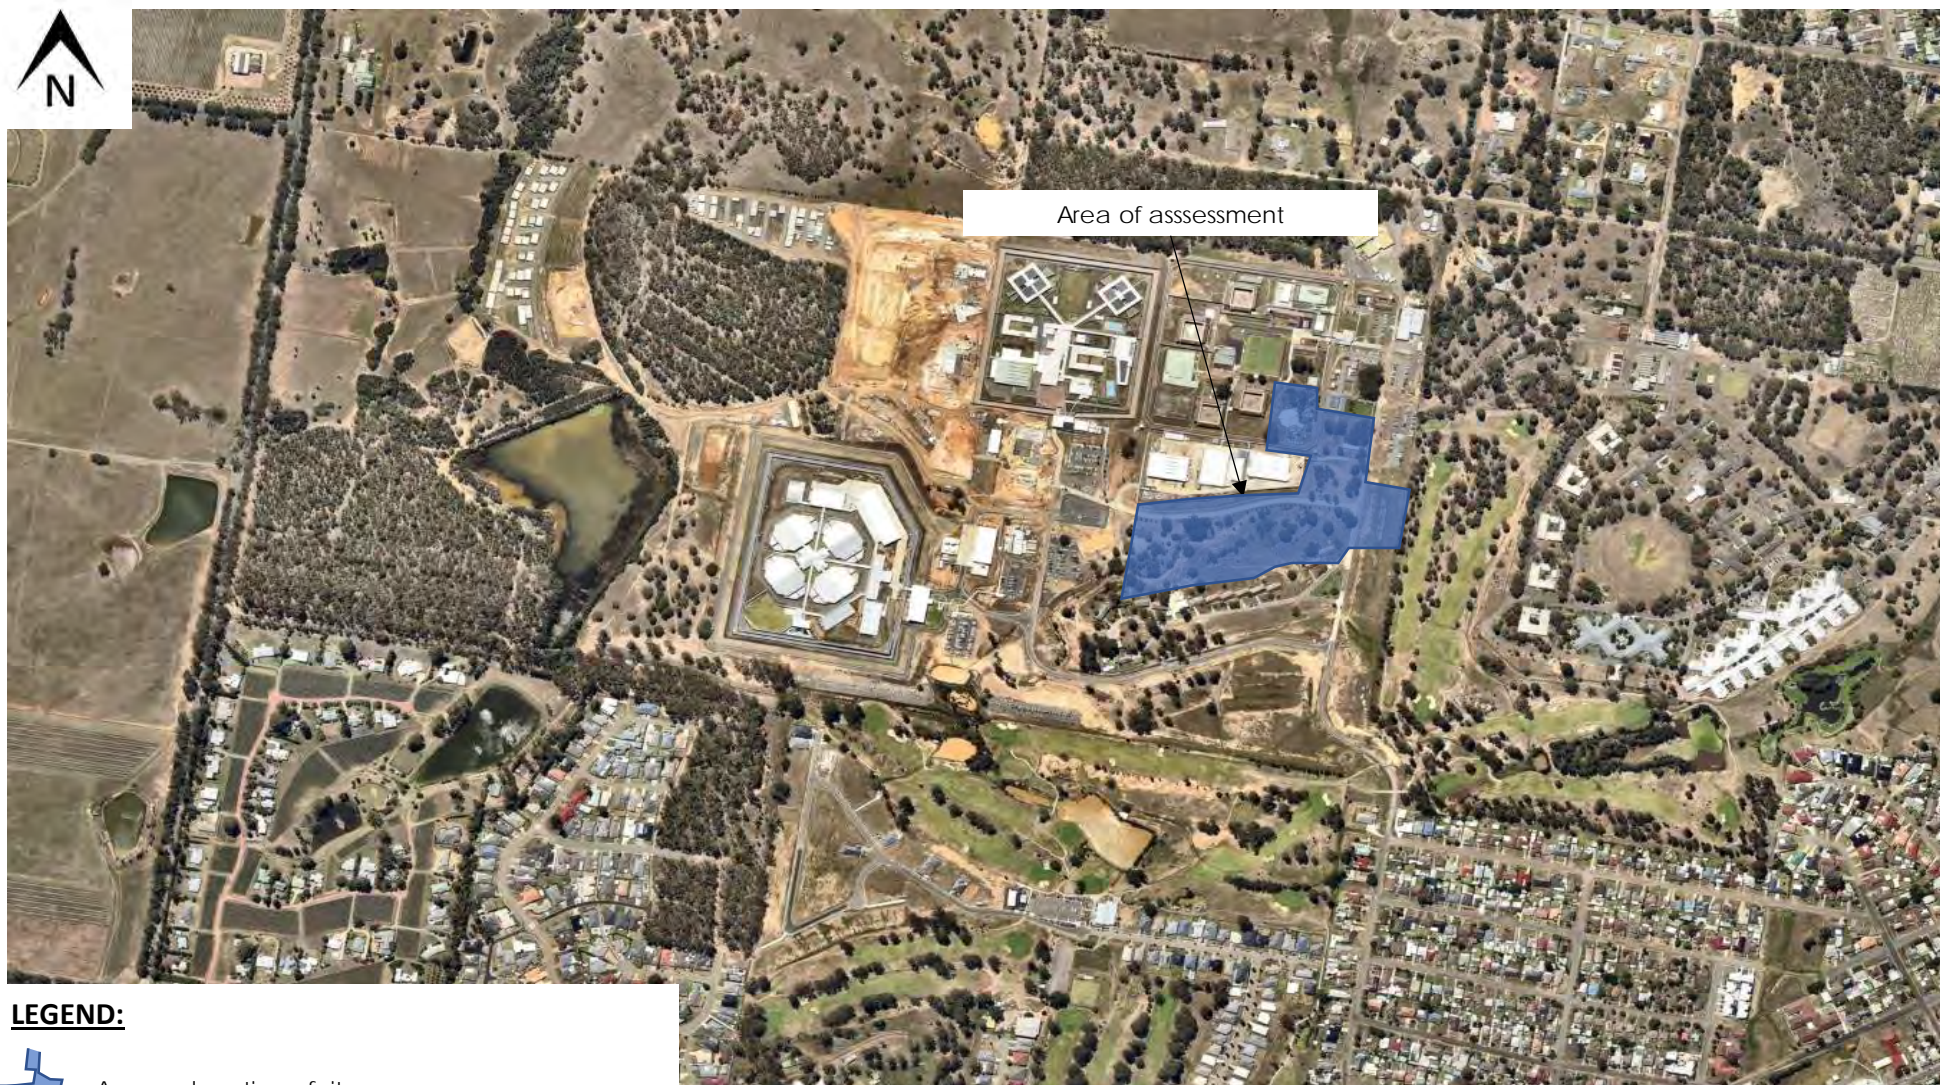
Figure 2 – Sample locations and Asbestos Detected

- A Phase 2 Contamination Assessment was completed on the site by Qualtest in July 2018 (Ref: NEW18P-0117-AA, dated 2 July 2018 (Qualtest, 2018). Asbestos was detected in two samples, below the adopted human health guidelines. The location of the samples containing asbestos is shown in Figure 2:

- Sample SS2 - Chrysotile asbestos was detected in the form of loose fibre bundles (Fibrous Asbestos - FA). The asbestos was detected at 0.00022%, which is below the adopted guideline for residential land use (0.001%); and,

Client:	Lend Lease	Drawing No:	FIGURE 2
Project:	Cessnock Gaol 240 Minimum	Project No:	NEW18P-0117
Location:	Cessnock Gaol, Cessnock	Scale:	N.T.S.
Title:	Sample Locations & Asbestos Detected	Date:	14/06/2018

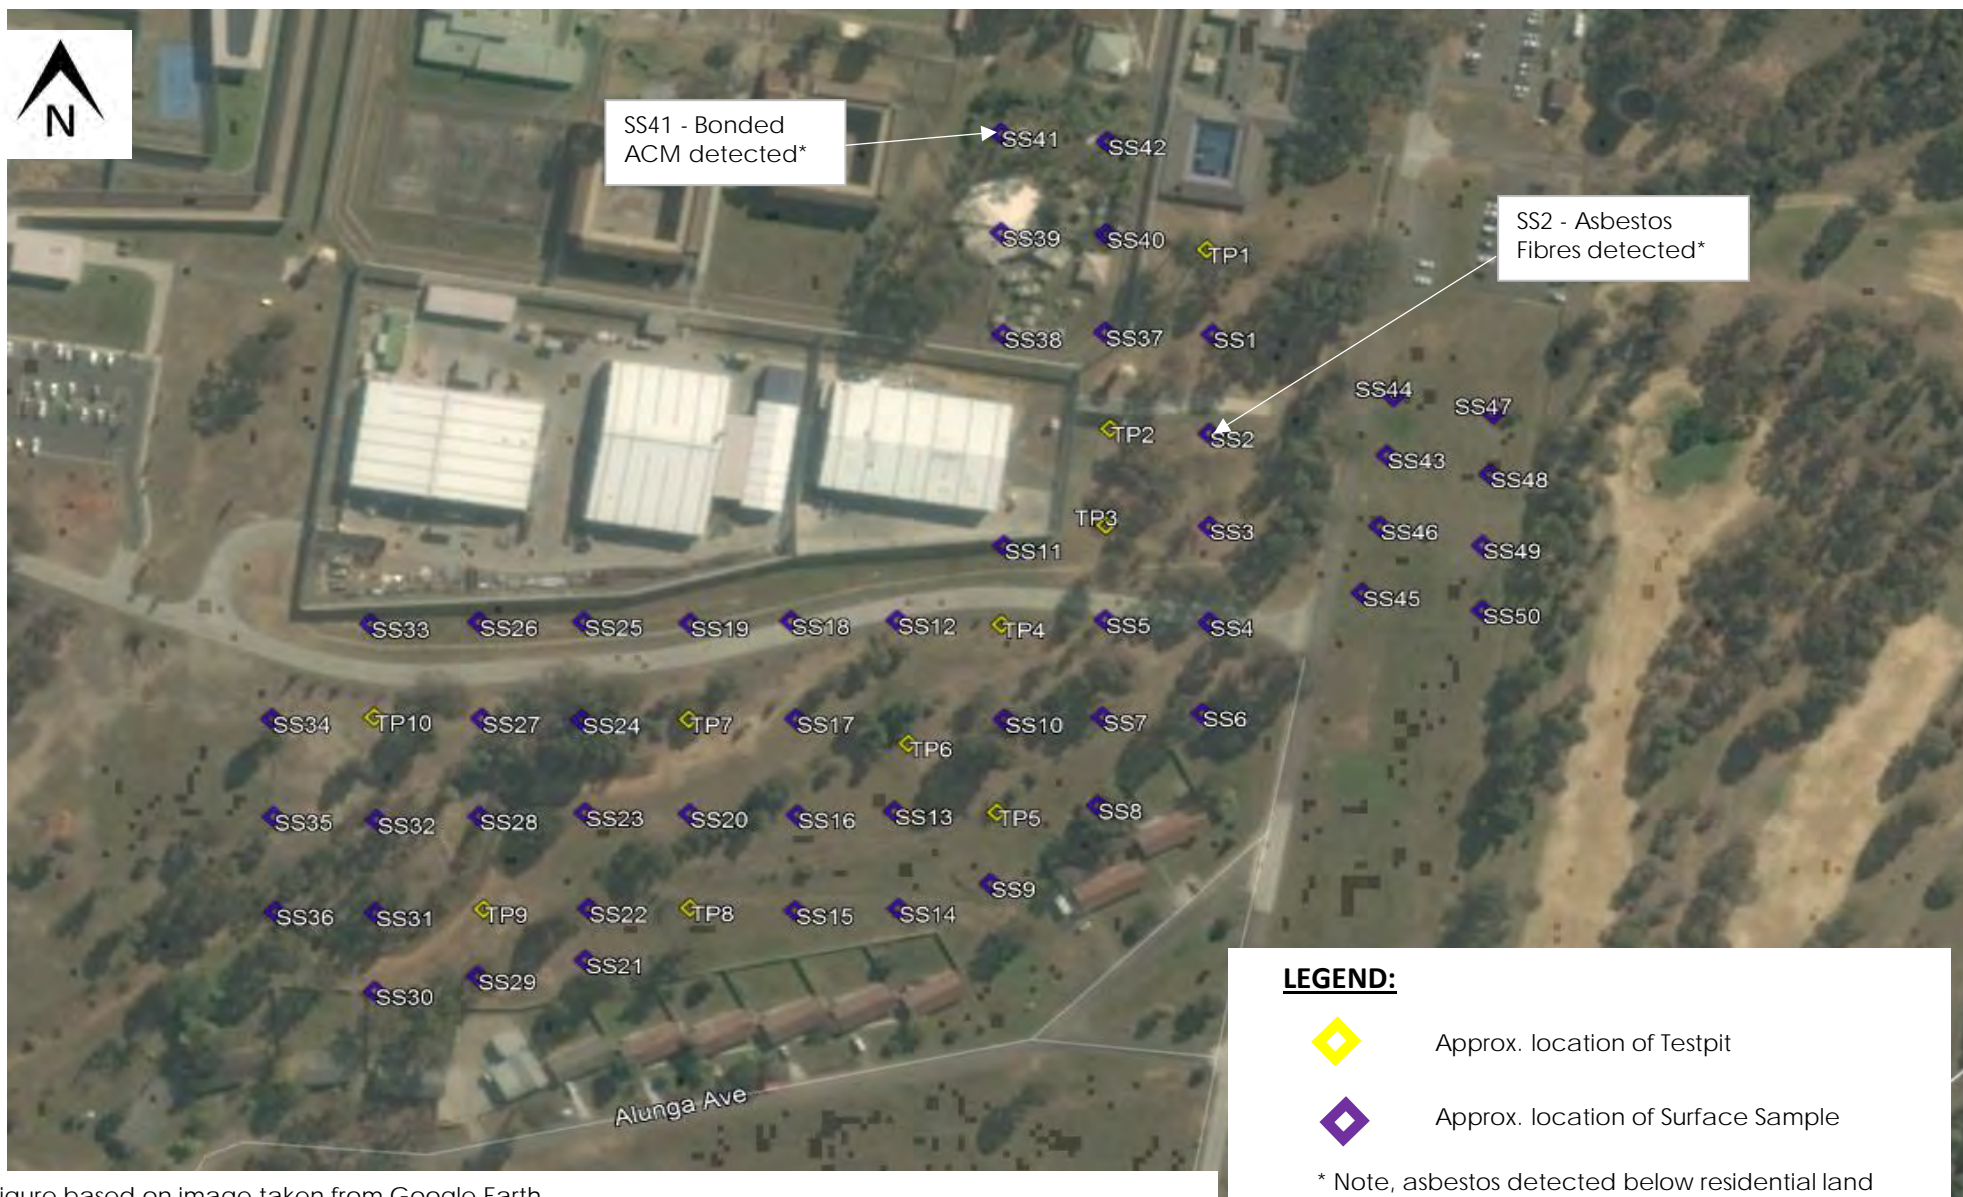
- Sample SS41 - Chrysotile and amosite asbestos was detected in a fragment of ACM (bonded asbestos). The concentration of ACM in the soil sample was calculated to be 0.0041%, which is below the adopted guideline for residential land use (0.01%).

The asbestos impacted material identified at sample location SS2 and SS41 will be excavated and placed under a building slab. Qualtest would recommend the following procedures for the excavation, transport and placement of the asbestos impacted materials:

- An area approximately 5m x 5m (i.e. 2.5m radius) around the sample location (i.e. SS2) would be excavated;
- The depth of impacted material will be assumed to extend to 0.1m and/or the top of the natural residual soils. This depth will be further confirmed by the asbestos clearance visual inspection, and sampling and analysis if fill materials are observed in the base of the excavation;
